**CANTERBURY'S ARCHAEOLOGY
2010 – 2011**

**35th annual report of the
Canterbury Archaeological Trust** 56

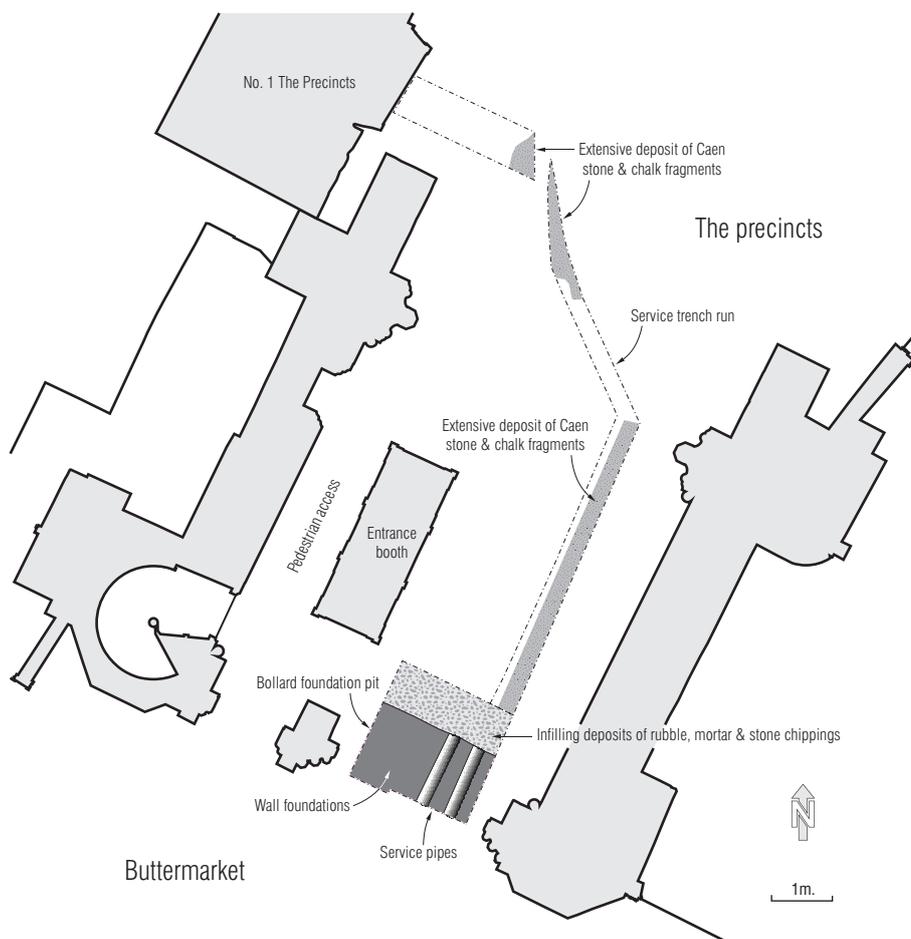
Fig 2. Trenches excavated within Christ Church Gate, and the principal archaeological remains uncovered (scale 1:125).

Uncovered within the bollard foundation pit were wide masonry remains running across the width of the gateway (east–west). They were cut, on their eastern side, by modern service runs. The lower levels were formed of large angular flints and rare ragstone fragments bonded with orange-brown mortar containing common small chalk lumps. The masonry was constructed with a lower offset supporting up to six courses of masonry, 0.80m high. Above, resting upon a thin skim of mortar, lay masonry of a different build, predominantly comprising large flint nodules, and rare chalk and ragstone fragments along with Tudor brick, bonded with light brown mortar containing common chalk lumps. The upper wall lay directly upon the earlier,

The upper masonry evidently forms part of the Christ Church Gate which stands today, the remains modifying earlier walling to form substantial bridging foundations for the monumental gateway. An interpretation of the lower fabric, however, needs to consider the history of the gate site prior to the erection of the current edifice.

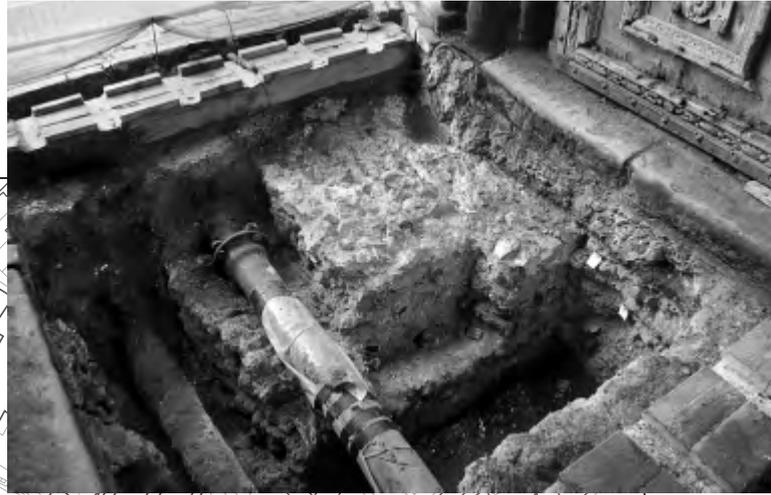
Two phases of wall foundation revealed within the Christ Church Gate bollard pit, looking south-west. Note the lighter mortar of the upper course. The infilling deposits of rubble, mortar and stone chippings, previously in the foreground, have been removed, but are visible in the labelled section bottom right.

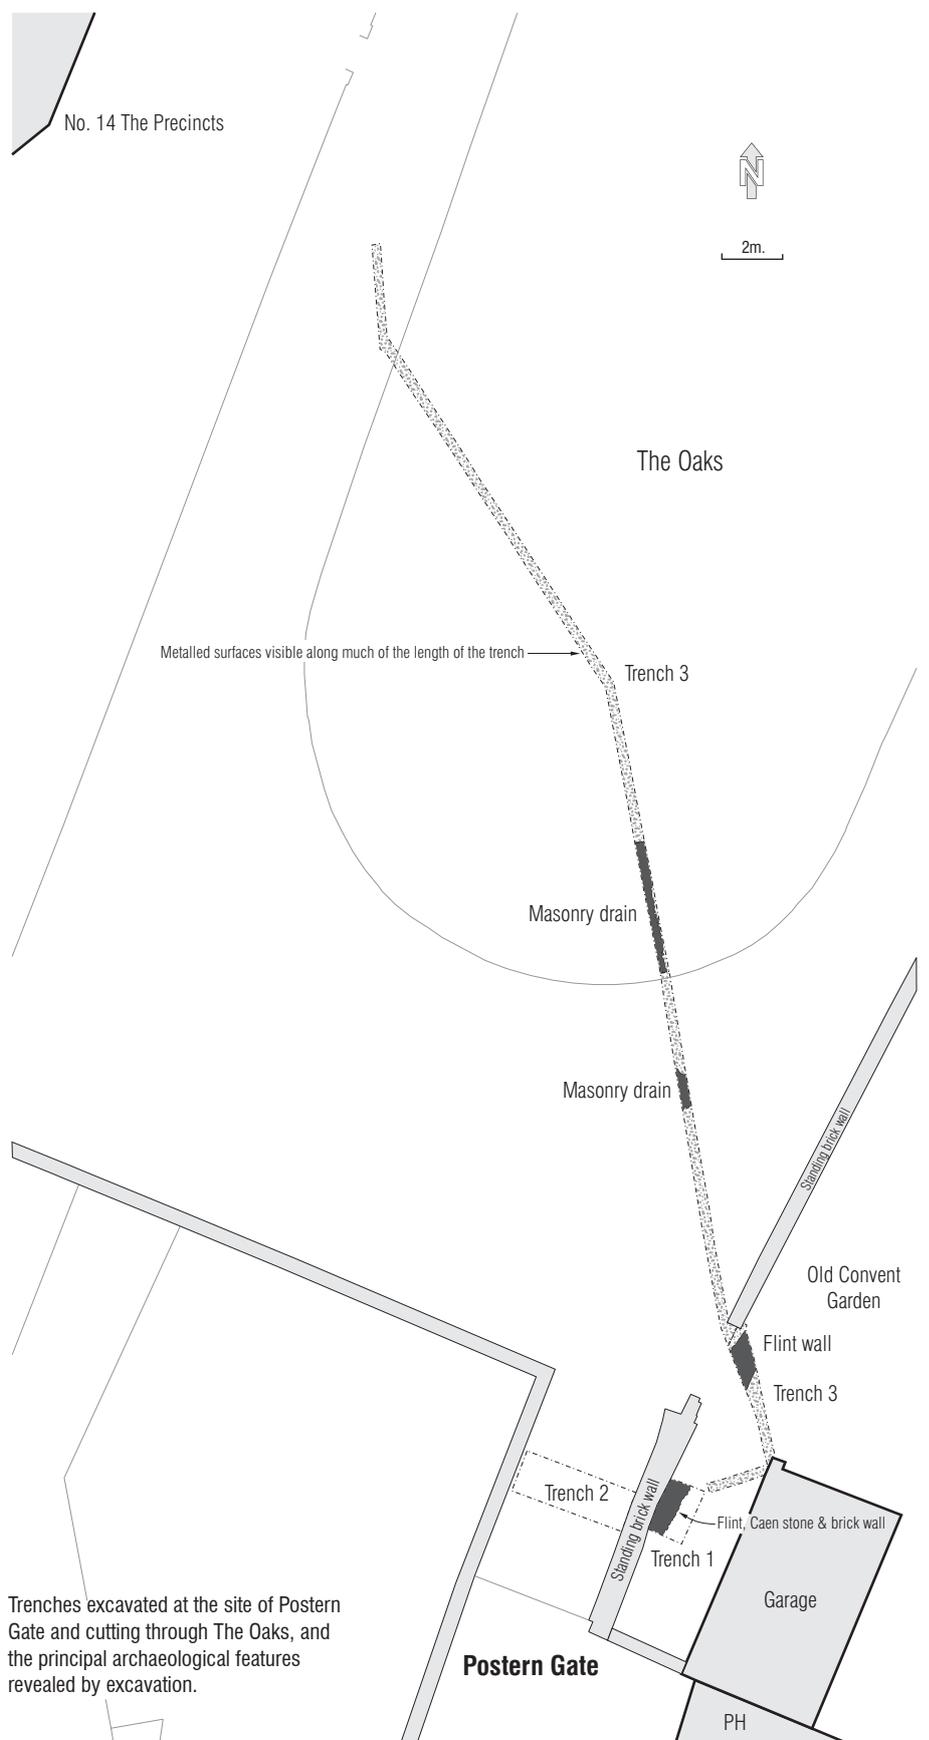
Trenches excavated at the site of Postern Gate and cutting through The Oaks, and the principal archaeological features revealed by excavation.

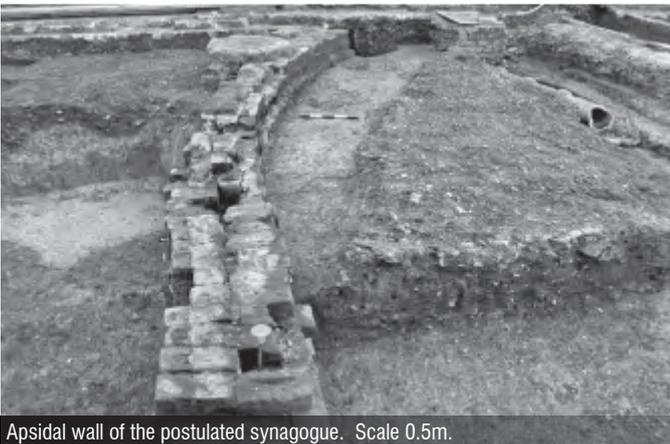
Apsidal wall of the postulated synagogue. Scale 0.5m.

with brick and tile drains. The western end of the south-eastern wall was apsidal, and it is postulated that these represent the remains of a synagogue constructed in 1763. The Andrews and Wren map of 1768 shows the rear of the site apparently occupied by a building labelled 'Jewish Synagogue'. Interestingly later maps such as Bayly's of 1795 and Barlow's of 1800 do not show this building, but mark a building on St Dunstan's Street further north-west as the synagogue (beyond the line of the later railway). The date of the wall foundations and their location appear to correlate with the position of the synagogue on the Andrews and Wren map and

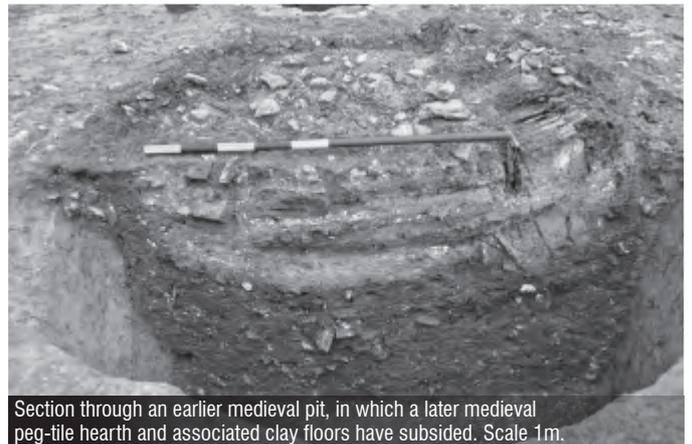
Section through an earlier medieval pit, in which a later medieval peg-tile hearth and associated clay floors have subsided. Scale 1m.

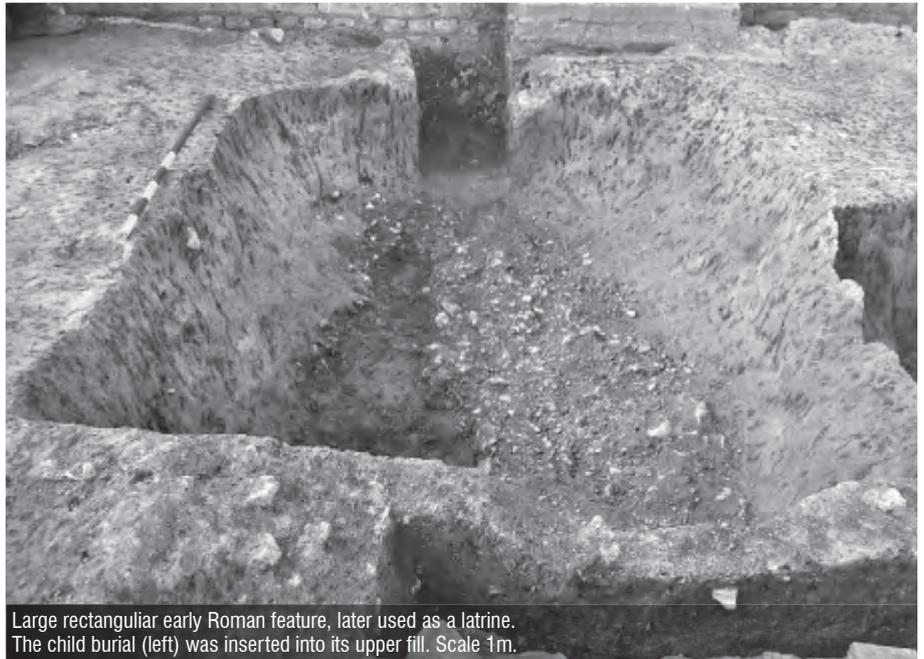
Large rectangular early Roman feature, later used as a latrine. The child burial (left) was inserted into its upper fill. Scale 1m.

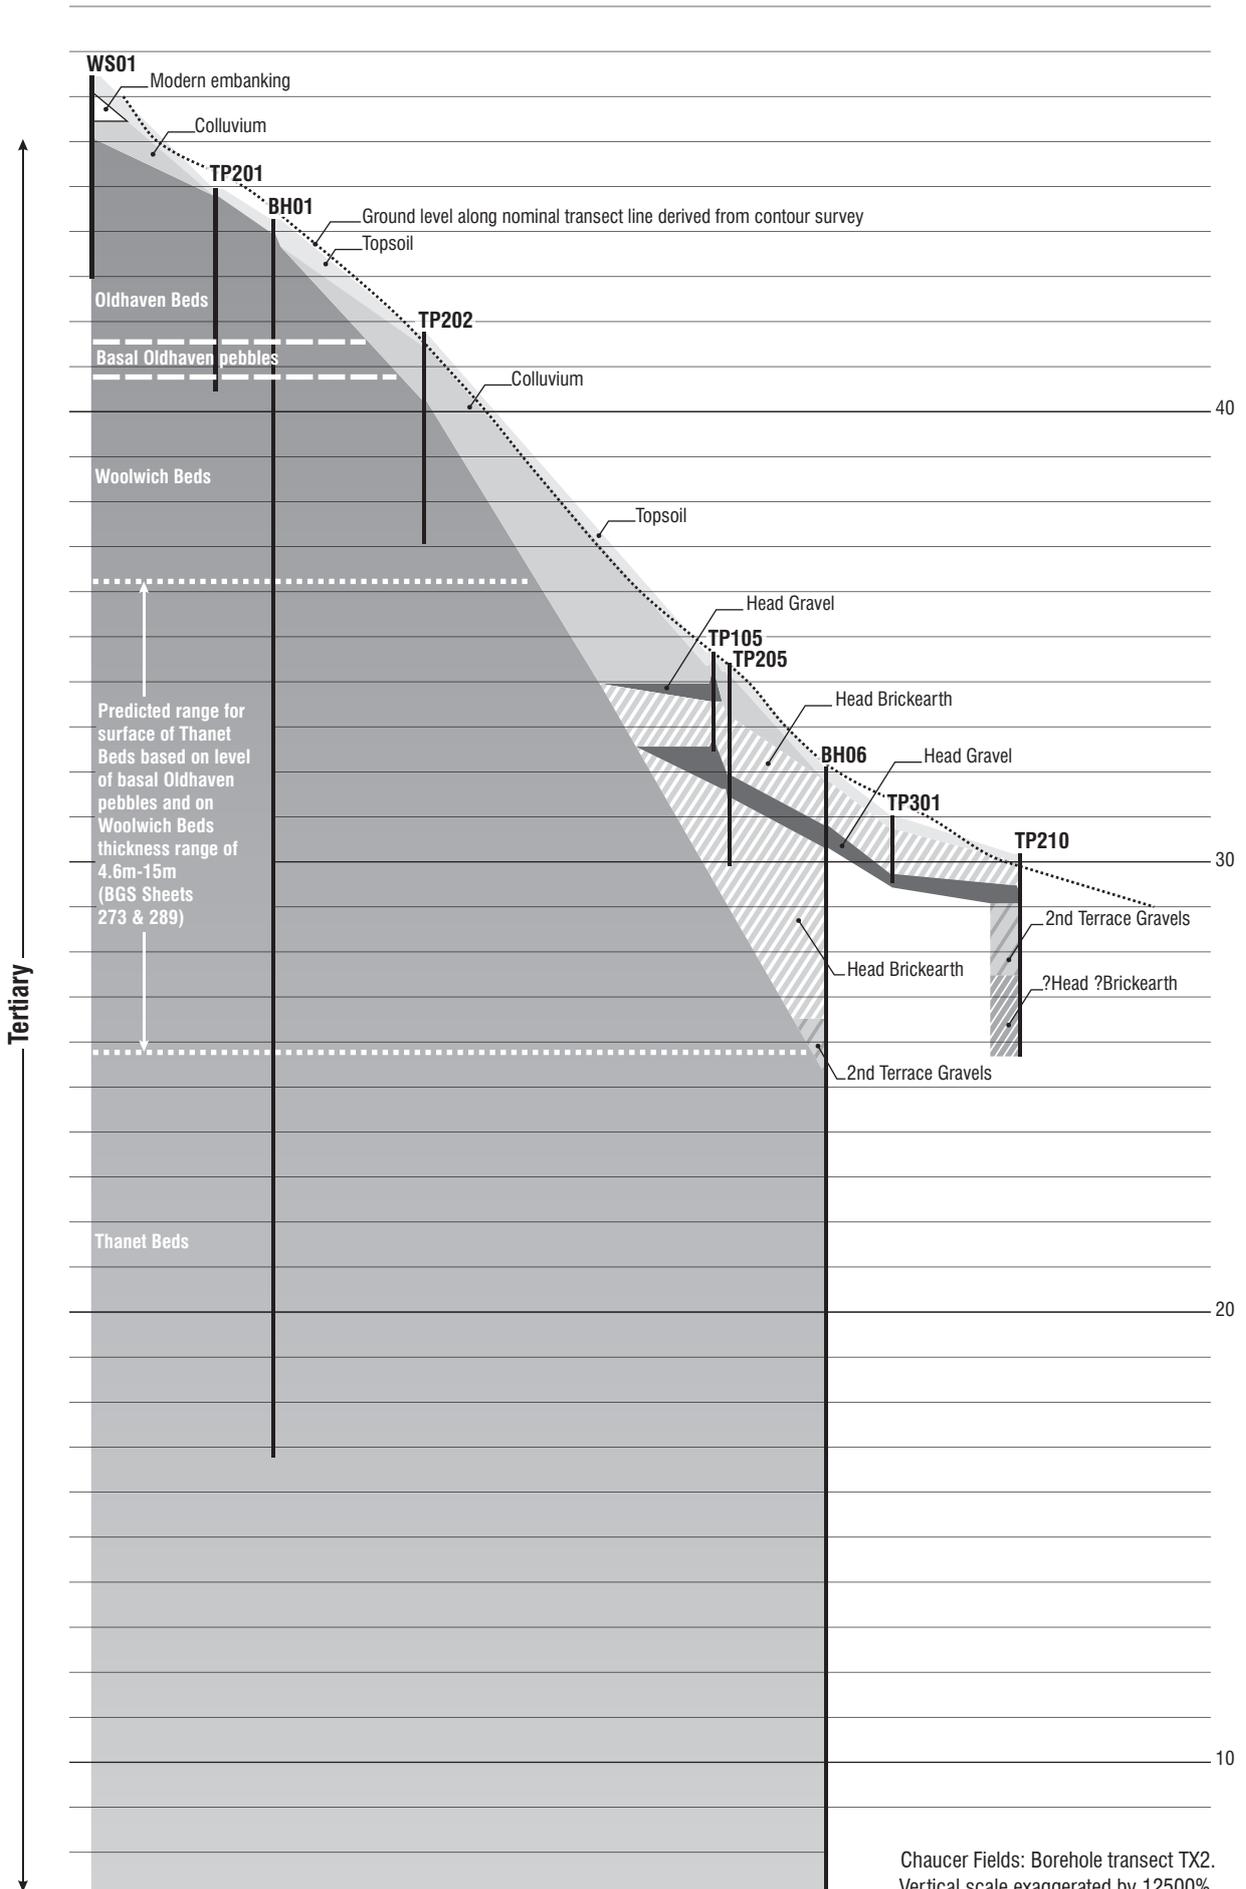
Chaucer Fields: Borehole transect TX2. Vertical scale exaggerated by 12500%.

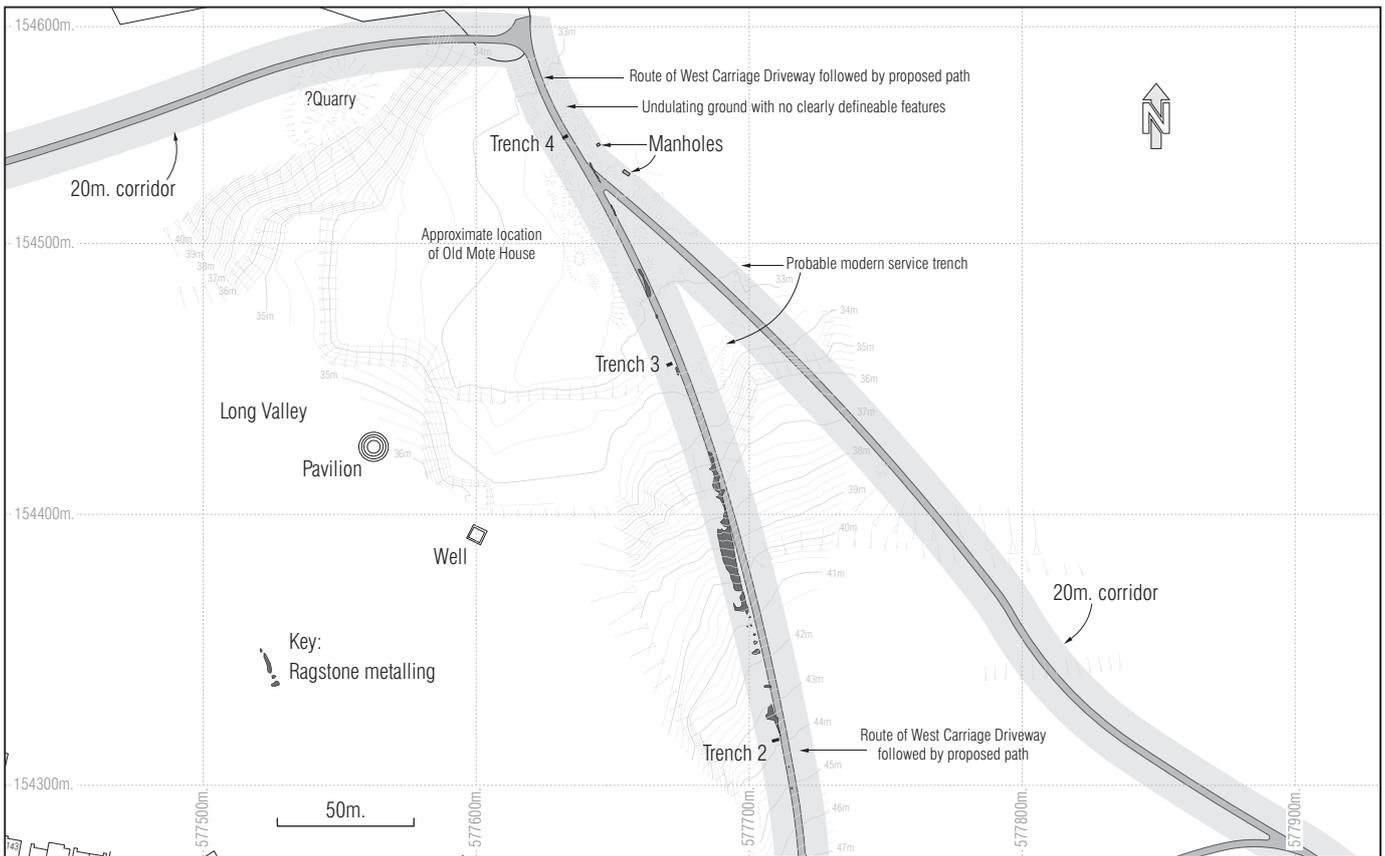
Topographic survey showing carriage driveway and Old Mote House area.

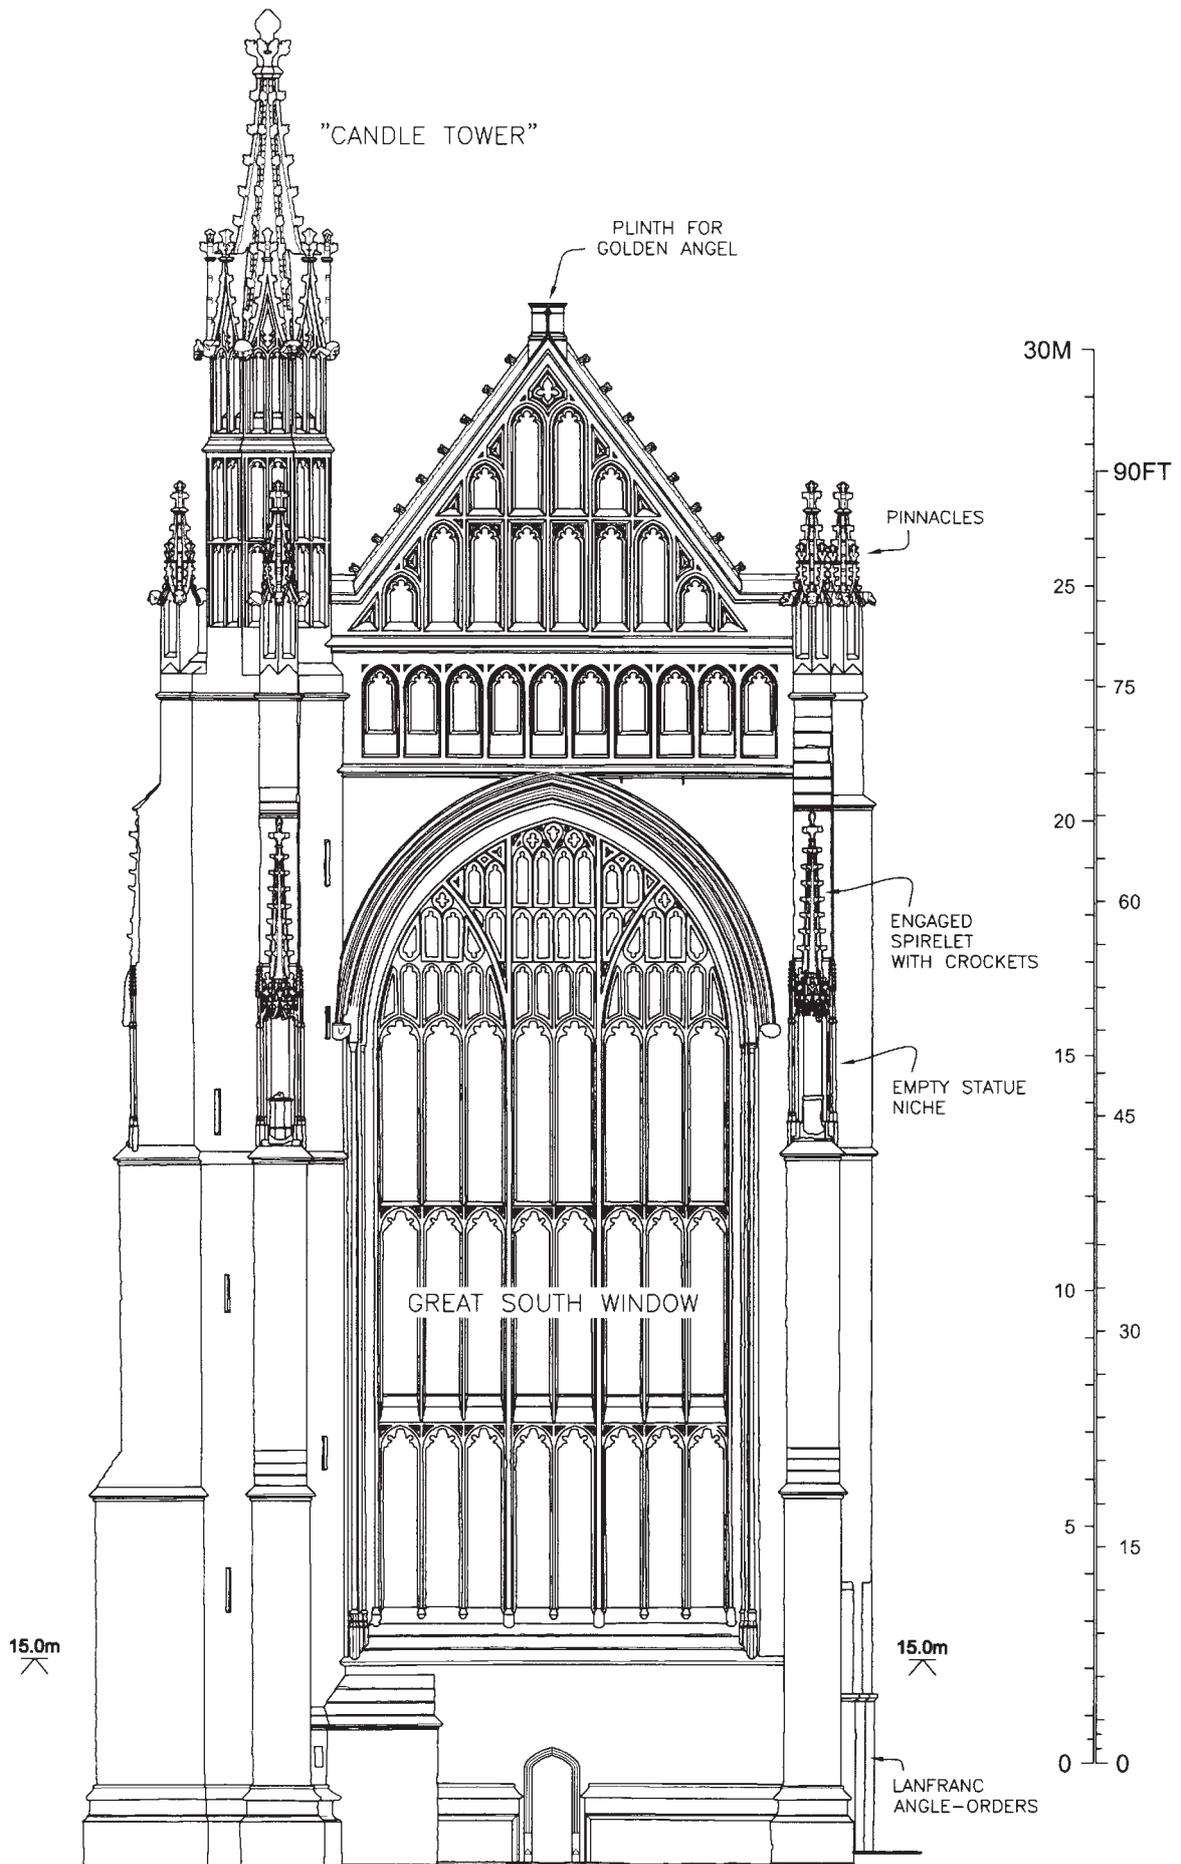
3 South-west transept, south elevation (Base survey Downland Partnership).

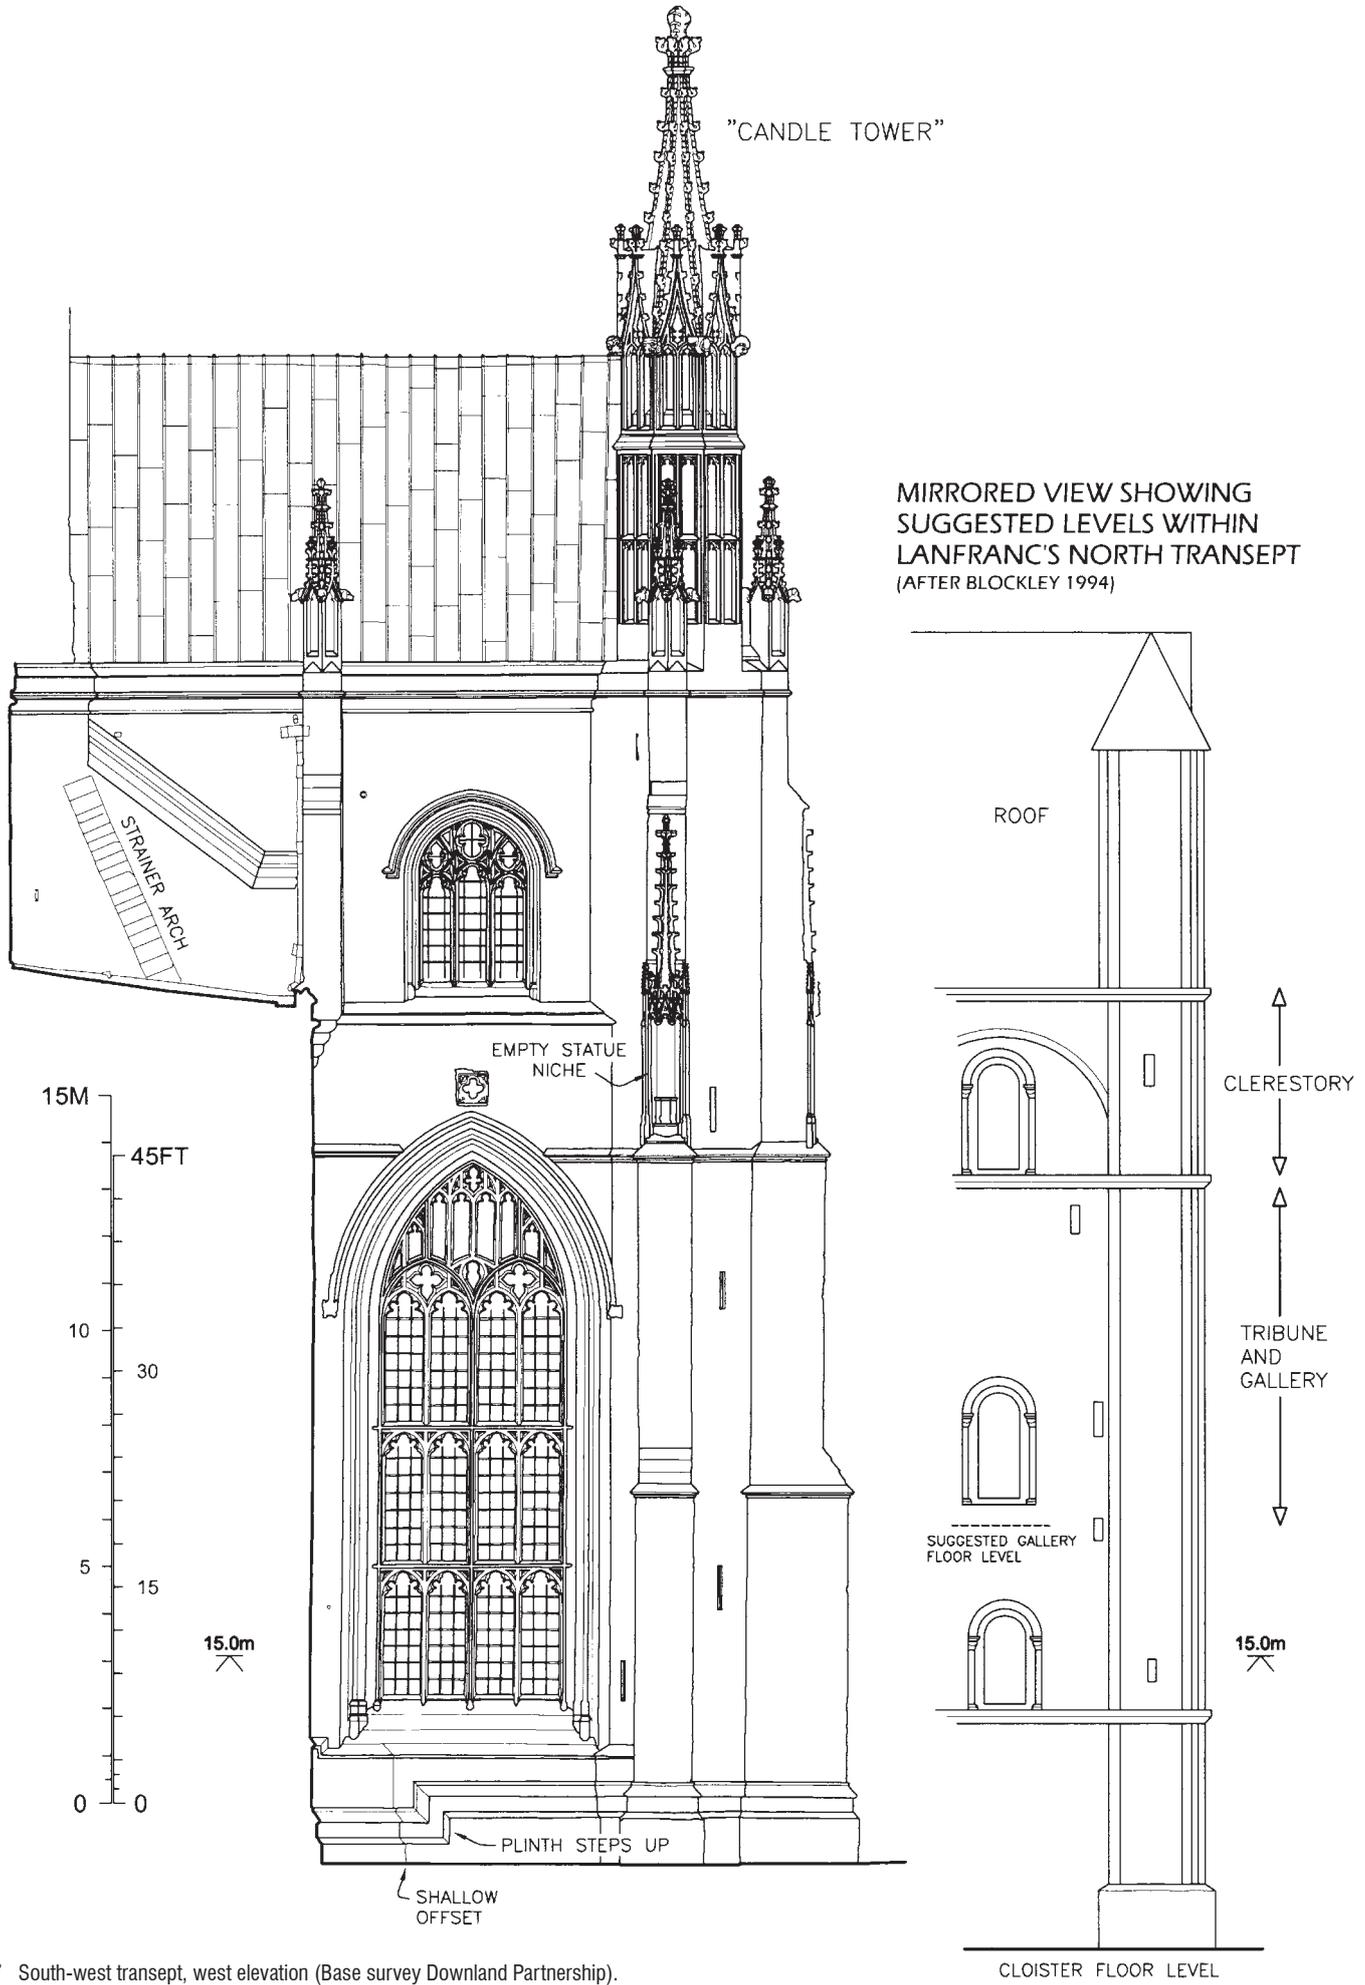
7 South-west transept, west elevation (Base survey Downland Partnership).

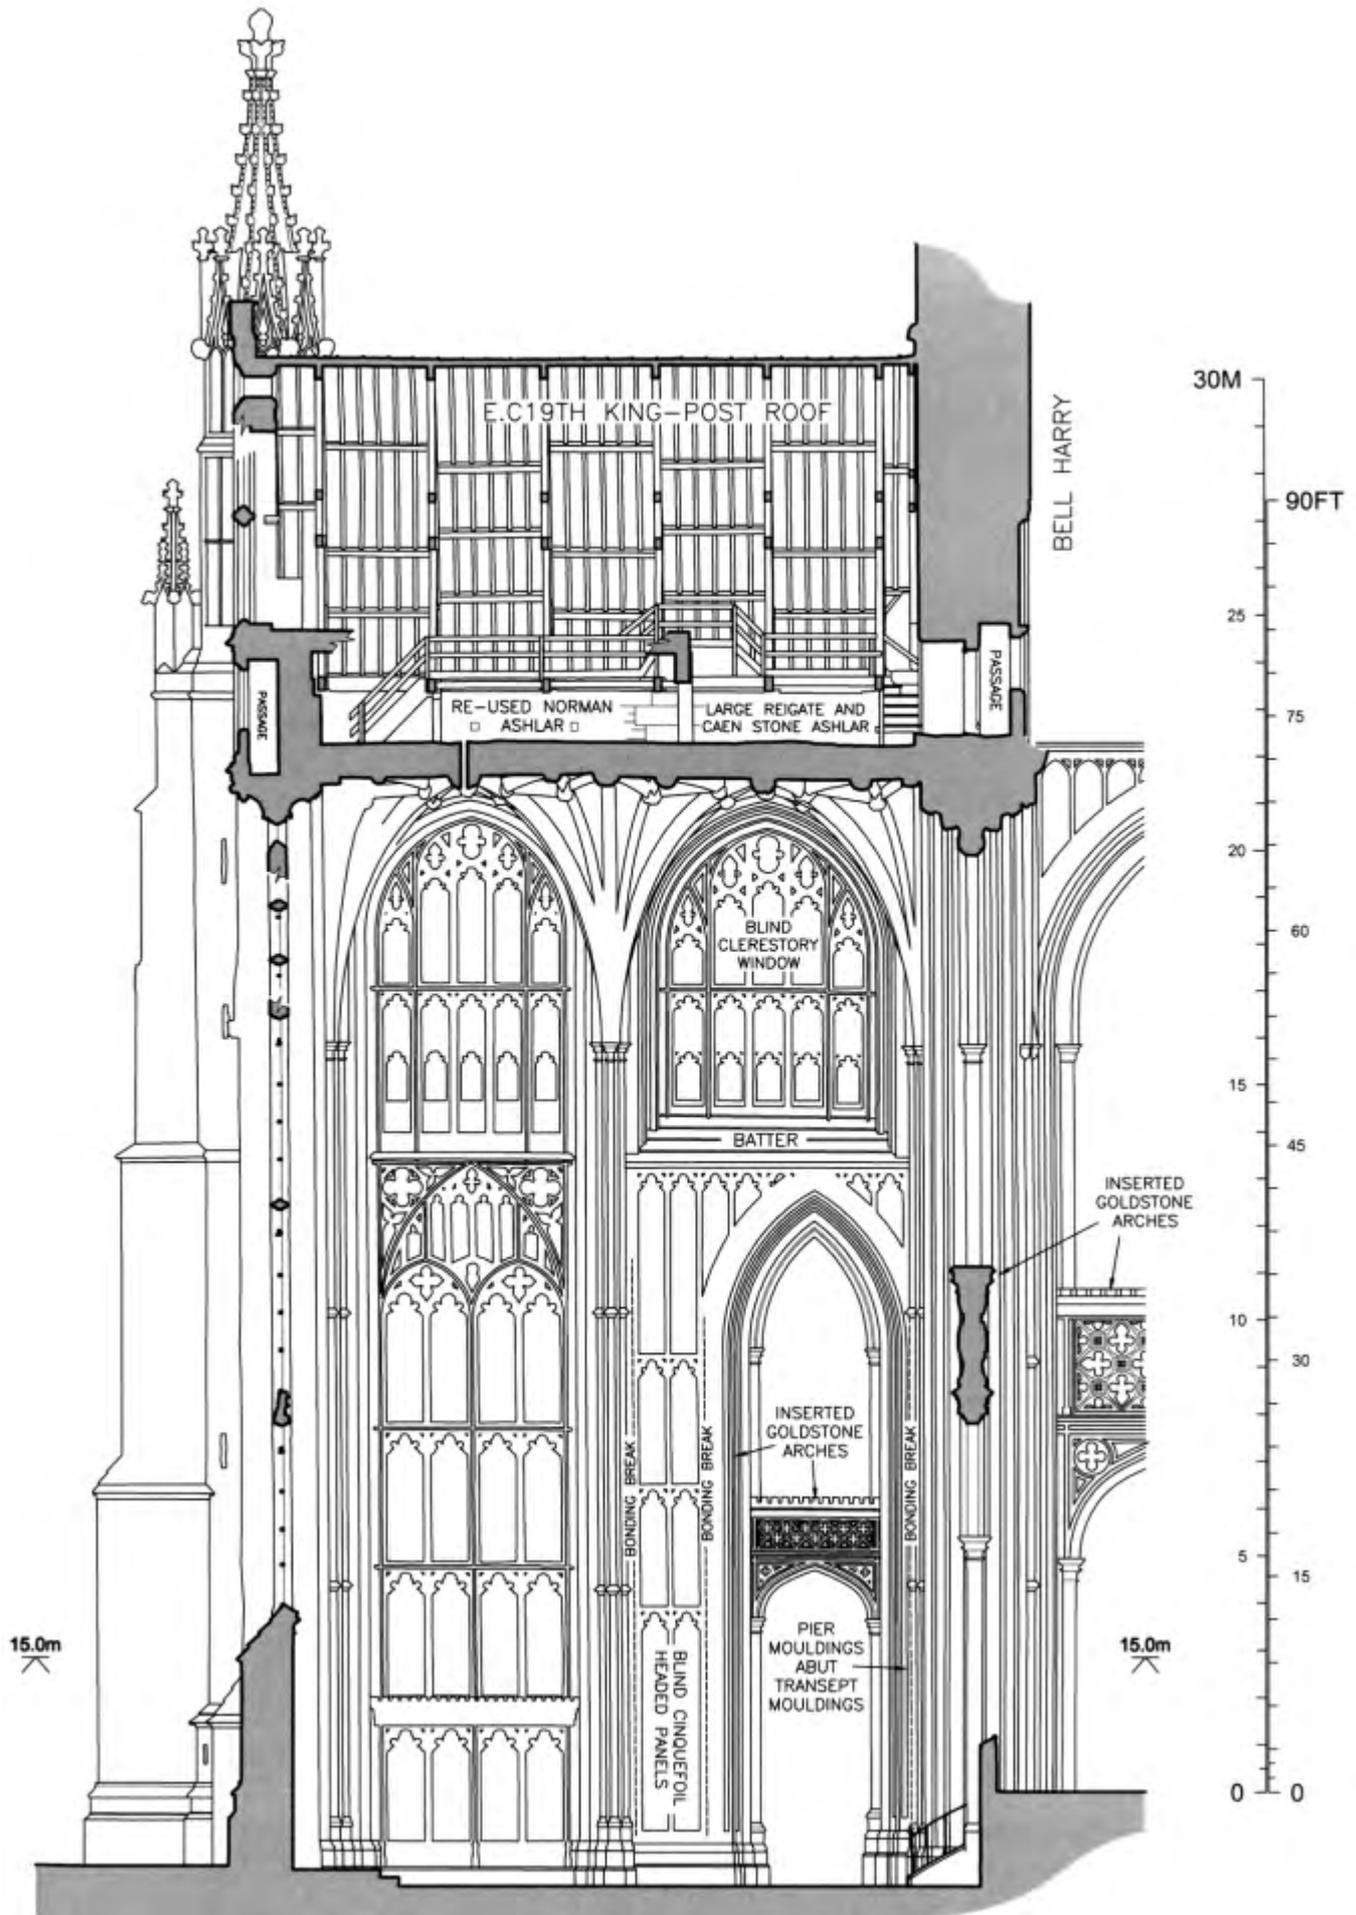
9 South-west transept, sectional elevation to west (Base survey Downland Partnership).

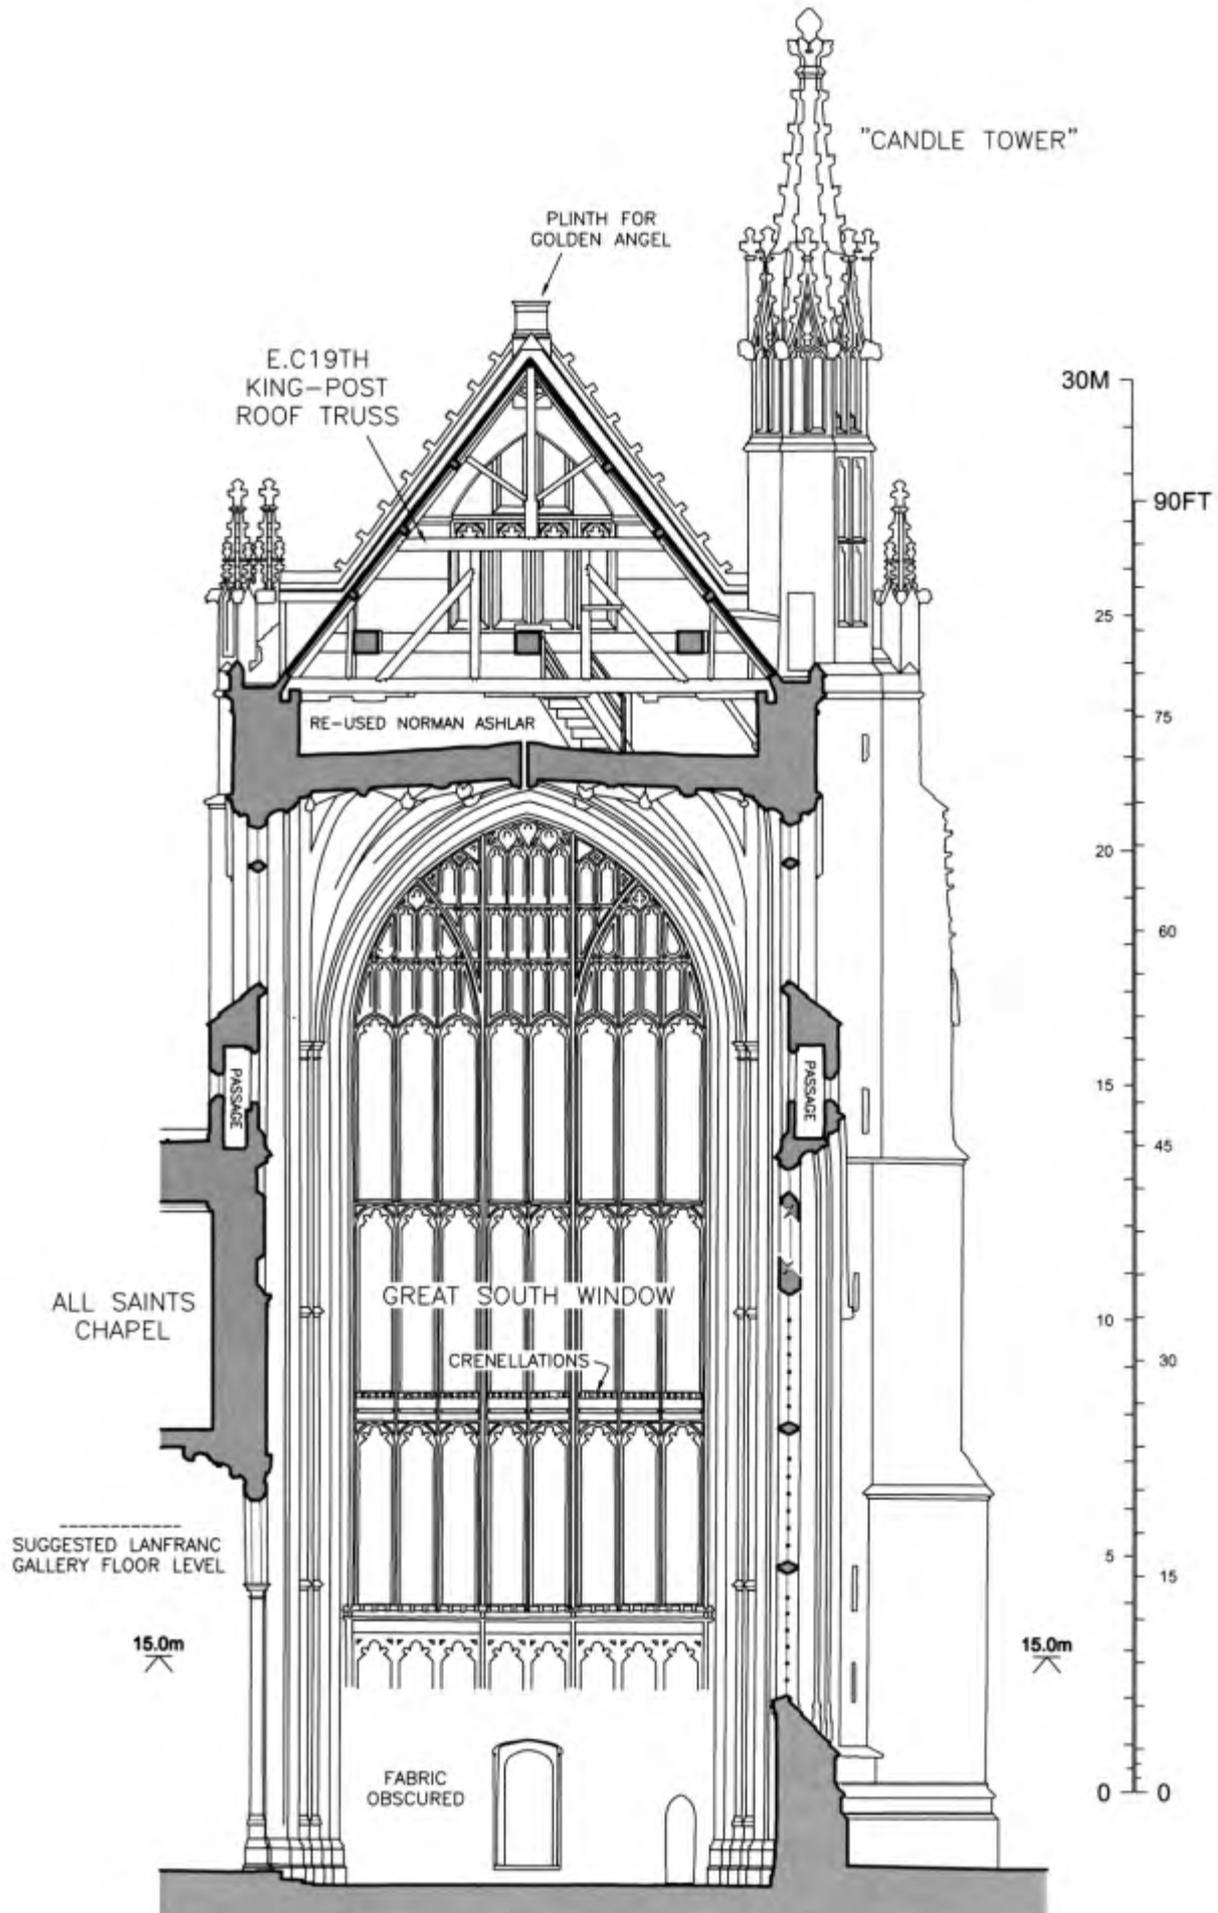
11 South-west transept, sectional elevation to south (Base survey Downland Partnership).

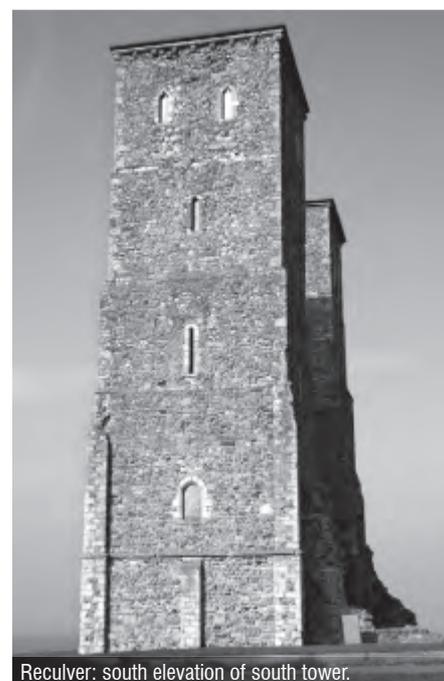
Reculver: south elevation of south tower.

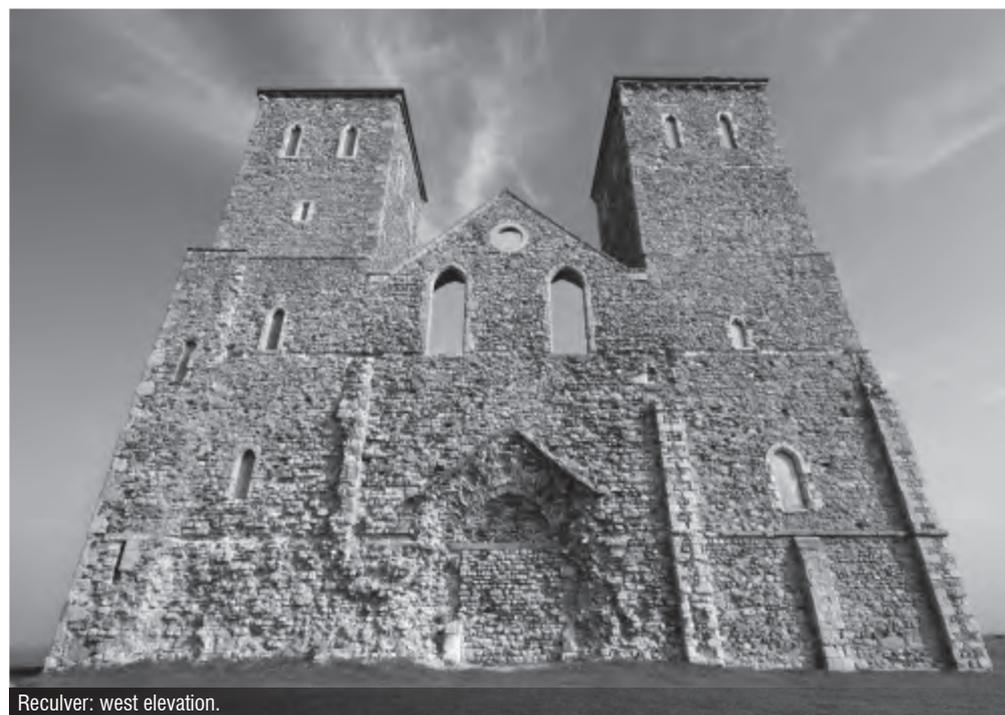
Reculver: west elevation.

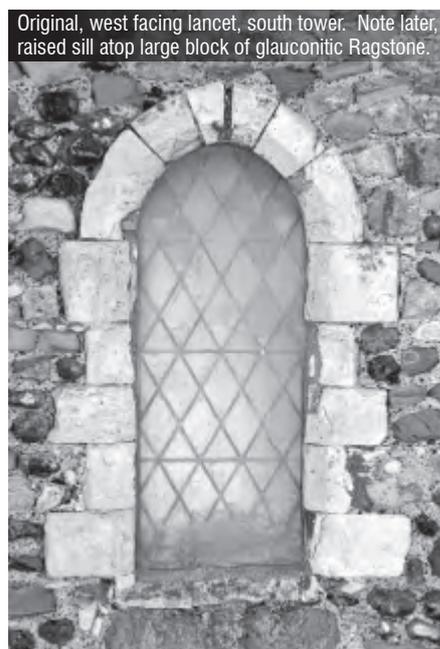
Original, west facing lancet, south tower. Note later, raised sill atop large block of glauconitic Ragstone.

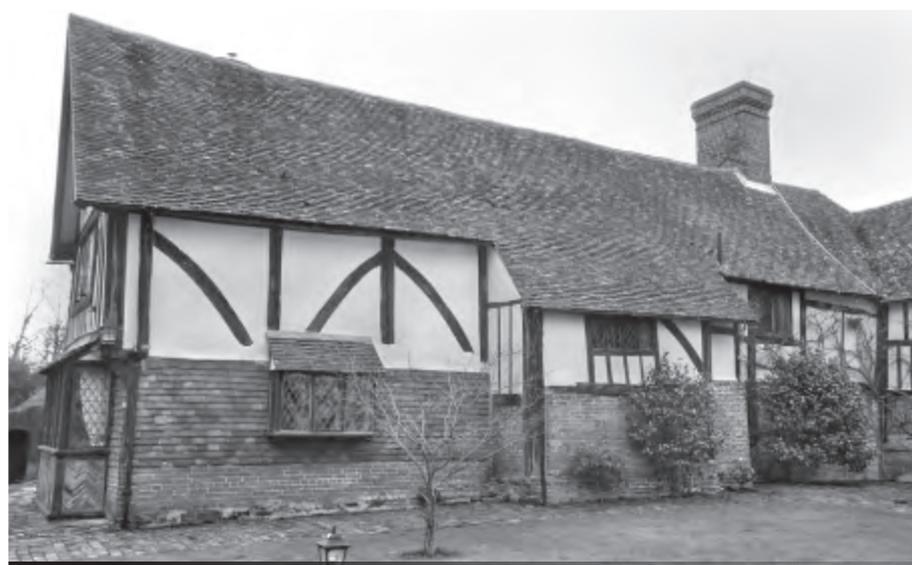
West elevation of the East Range, showing large panel framing with down-braces. Note projecting stair tower.
