**AR
36**

**CANTERBURY'S
ARCHAEOLOGY
2011 – 2012**

**36th annual report
of the
Canterbury
Archaeological
Trust**

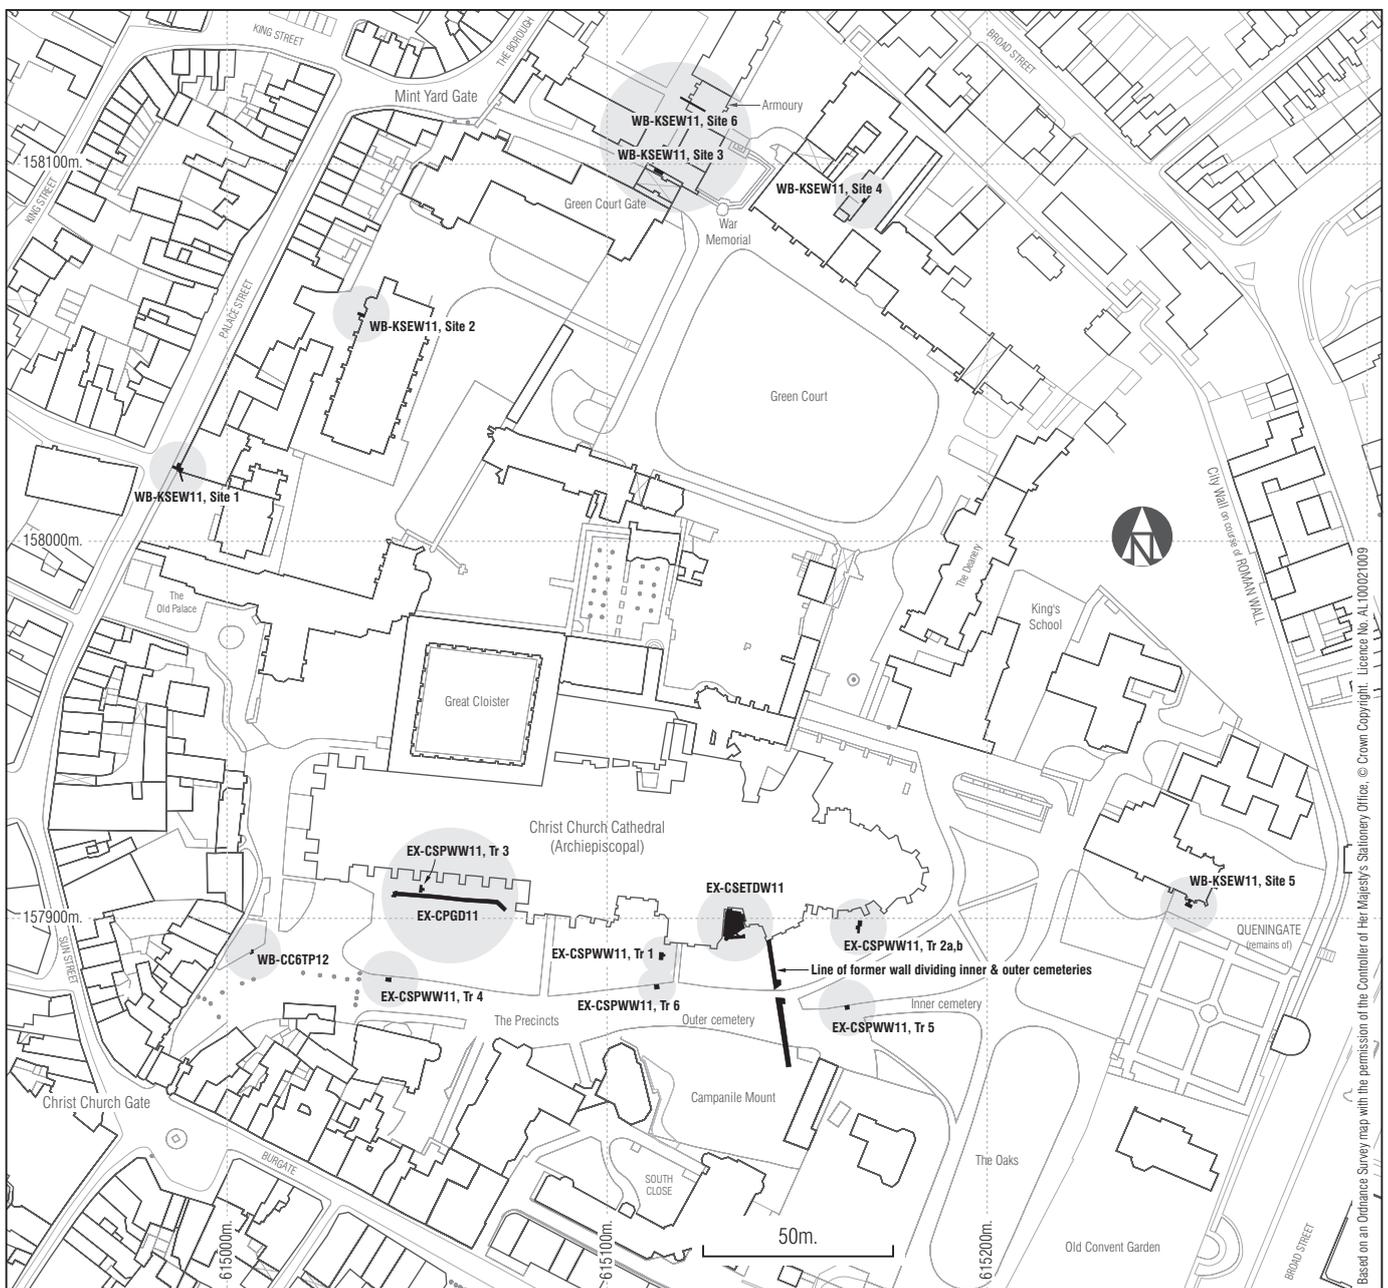
Canterbury Cathedral Precincts (scale 1:2000).

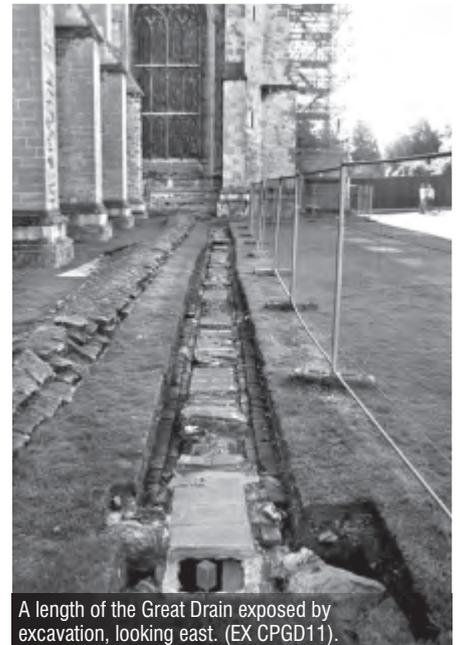
A length of the Great Drain exposed by excavation, looking east. (EX CPGD11).

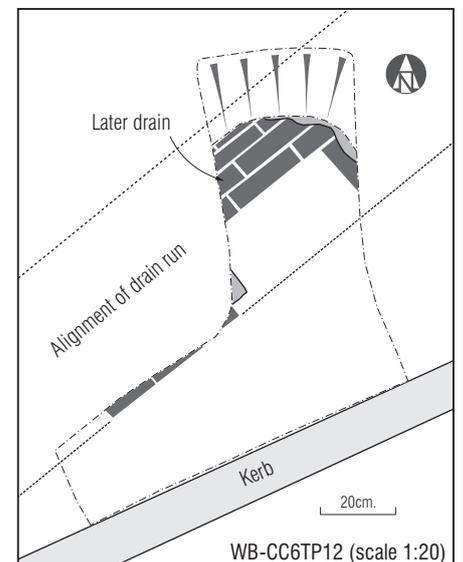
WB-CC6TP12 (scale 1:20)

Other, later, drains were also revealed during the archaeological works. Towards the west (WB-CC6TP12), a south-west to north-east aligned drain was revealed, dished in profile and constructed of hard-fired red bricks capped by horizontally laid, neatly cut limestone slabs. The channel was entirely infilled with a loose deposit of mid brown silty clay which indicated that the feature was no longer in use. The date of the drain is uncertain although it seems unlikely to have formed part of the monastic Great Drain since it differed so widely in construction. It was

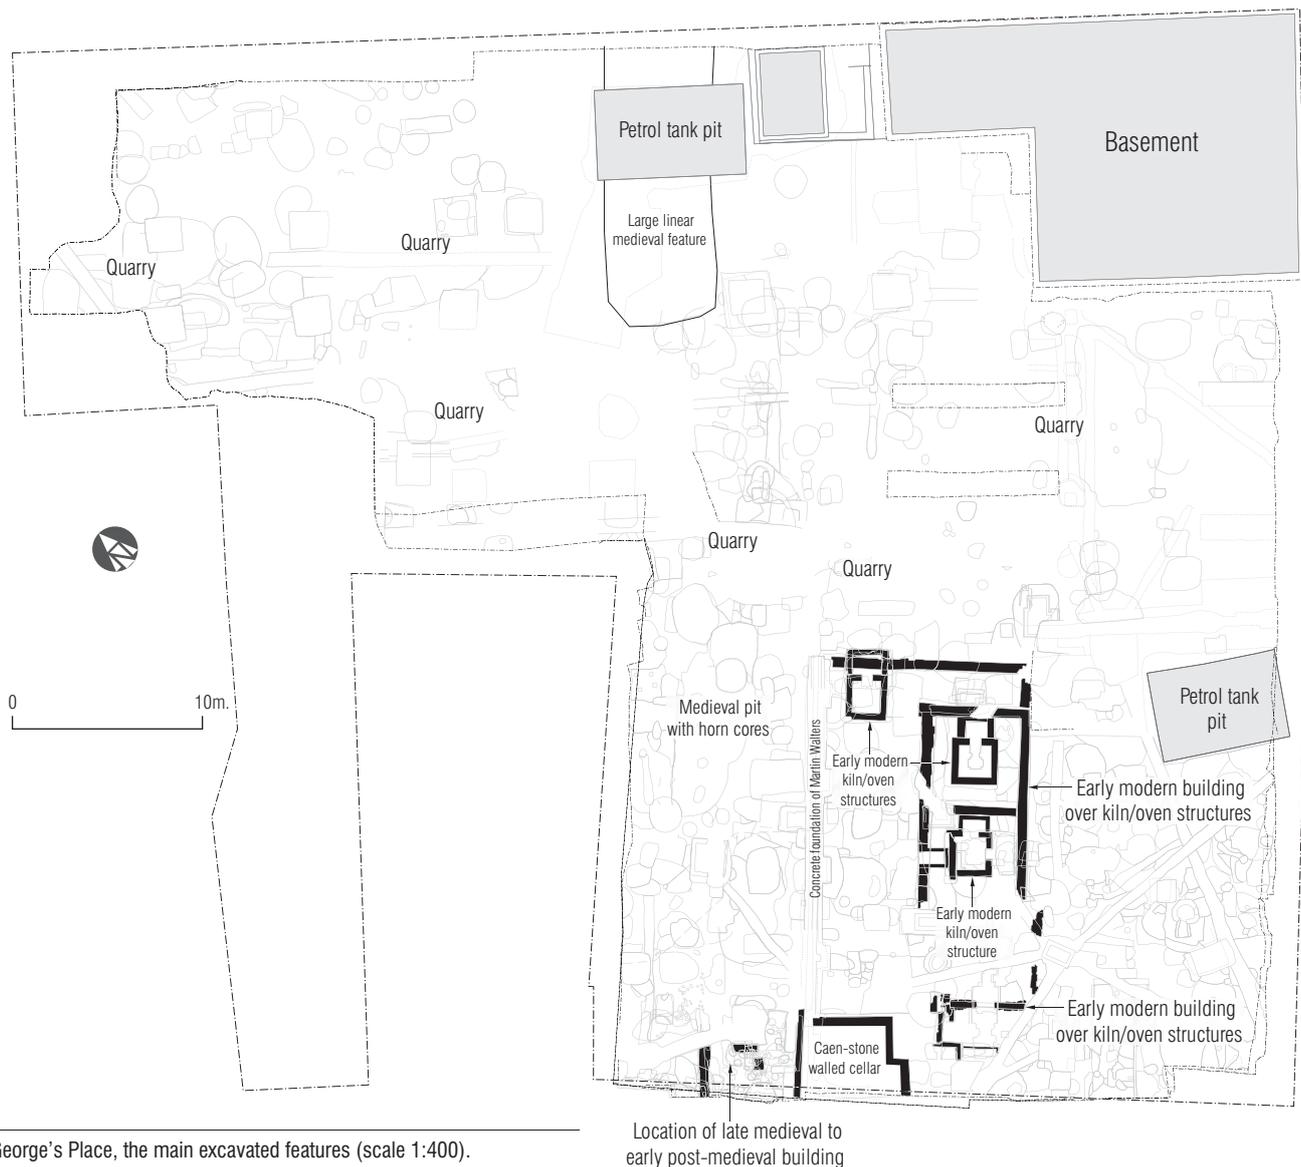
St George's Place, the main excavated features (scale 1:400).

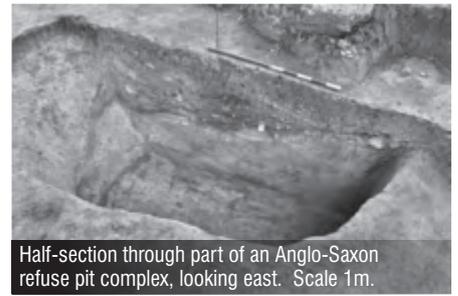
Half-section through part of an Anglo-Saxon refuse pit complex, looking east. Scale 1m.

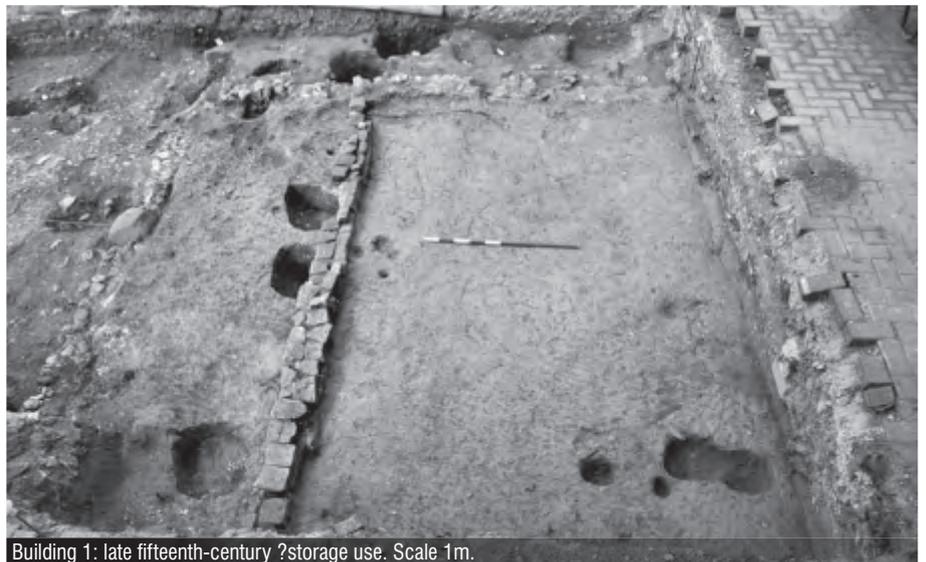
Building 1: late fifteenth-century ?storage use. Scale 1m.

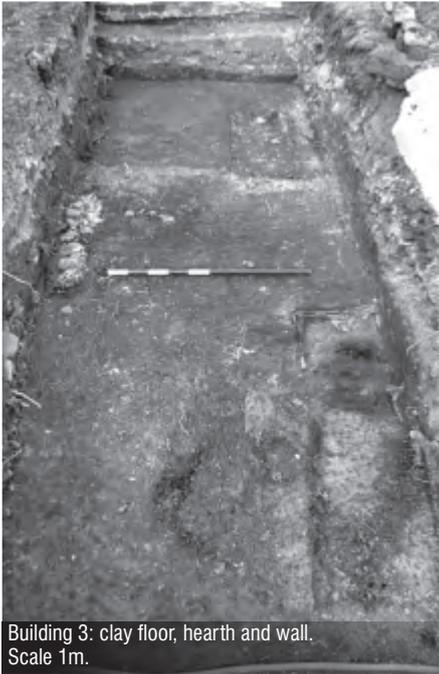
Building 3: clay floor, hearth and wall. Scale 1m.

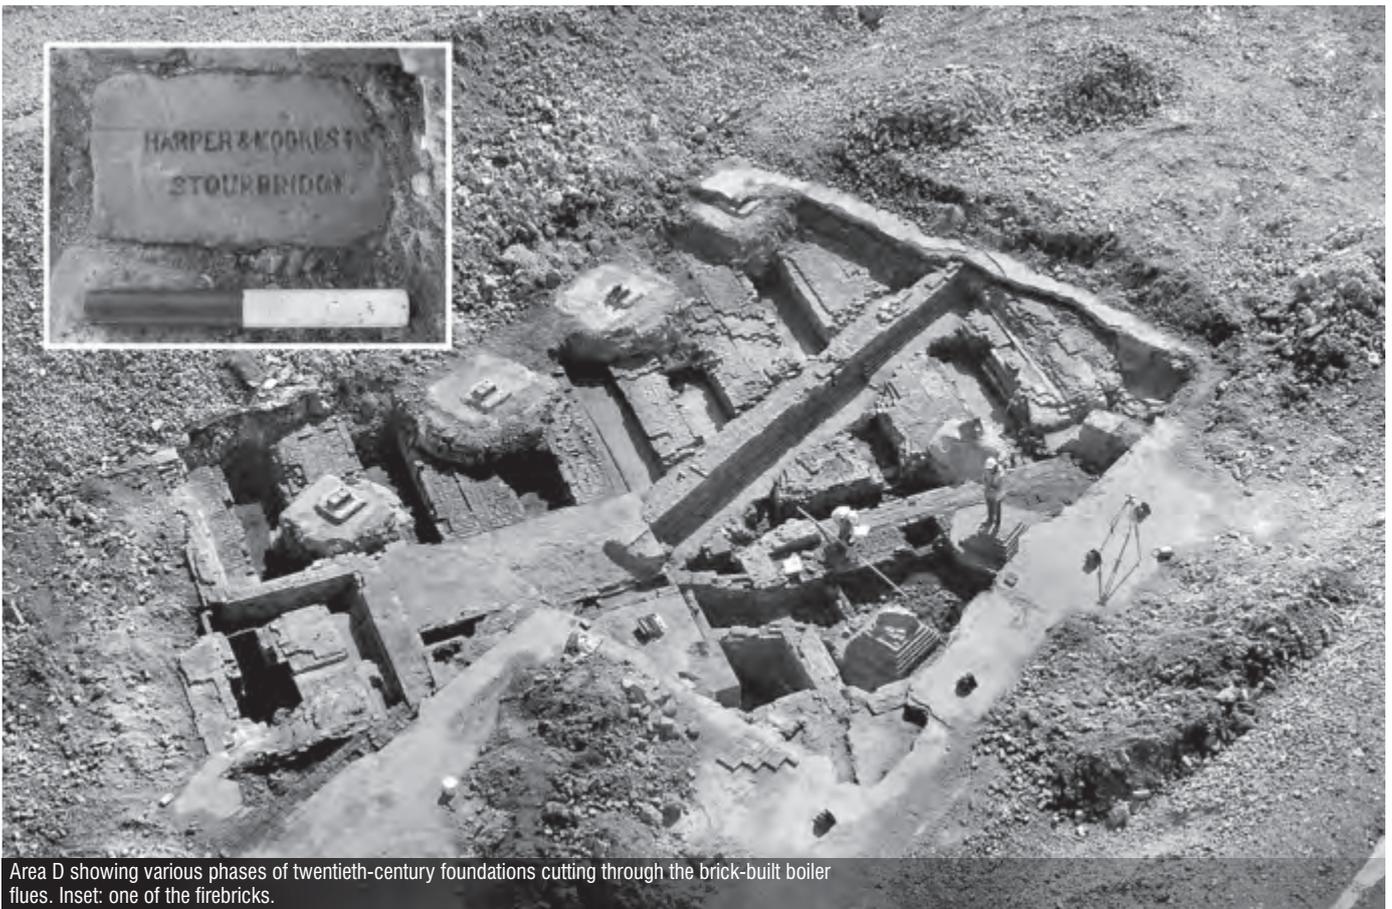
Area D showing various phases of twentieth-century foundations cutting through the brick-built boiler flues. Inset: one of the firebricks.

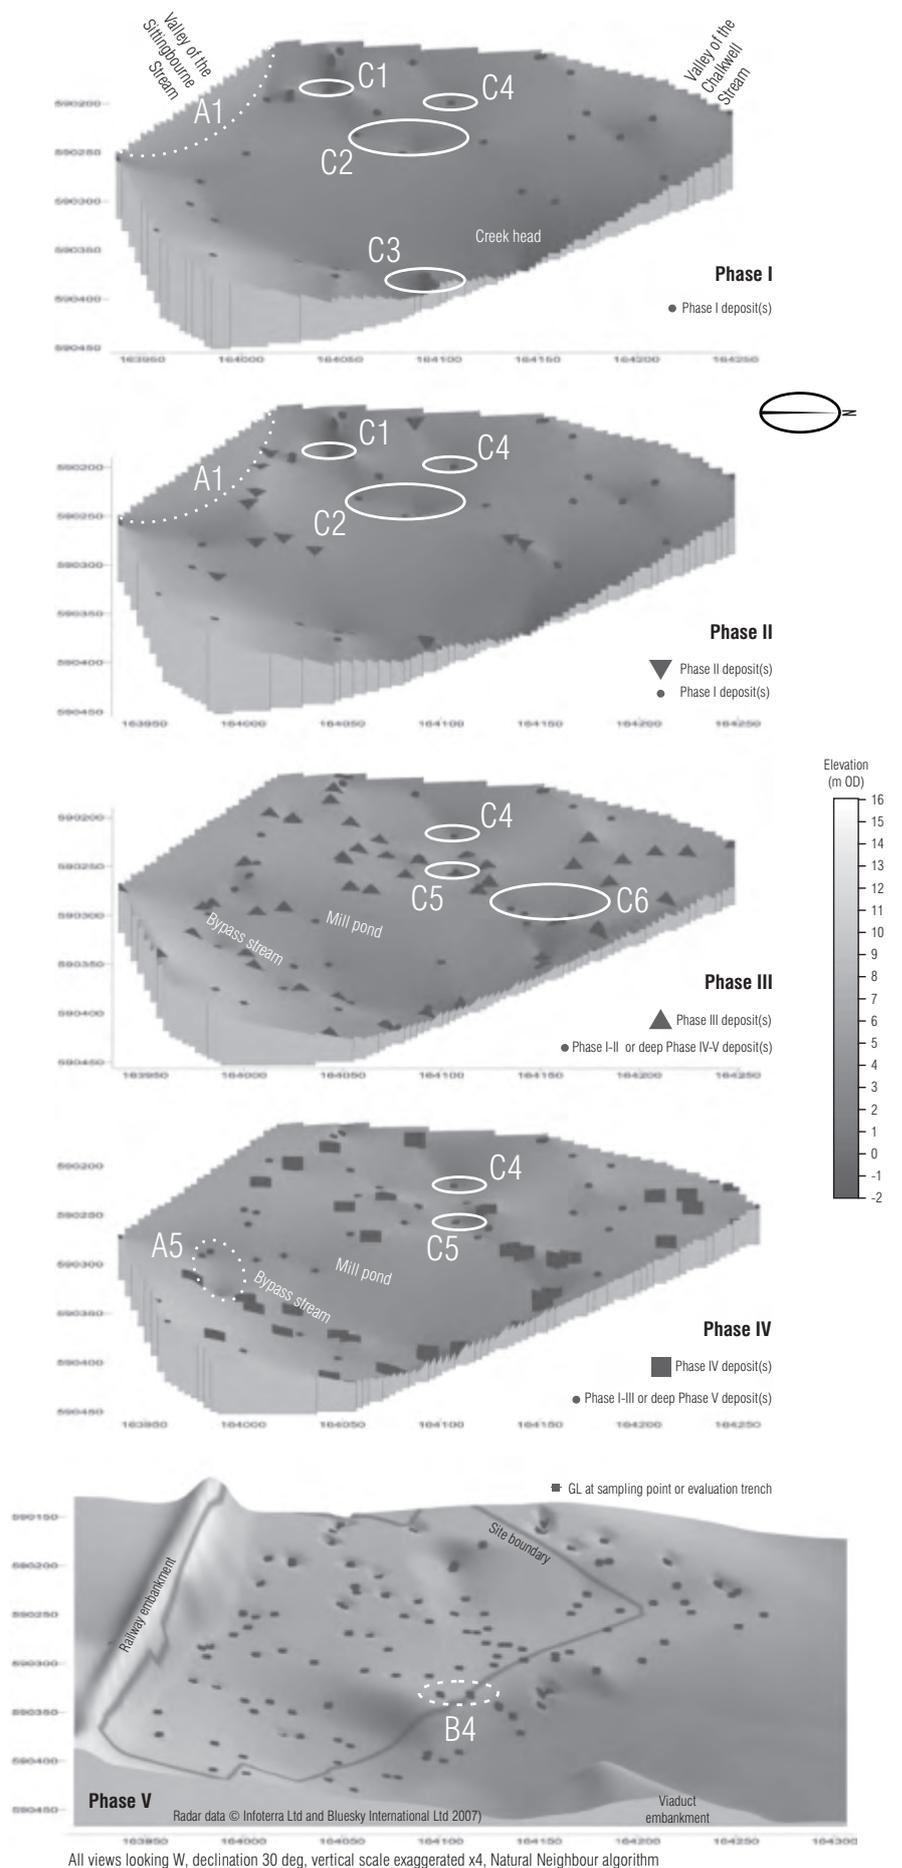
Sittingbourne Paper Mill: progressive infilling and main anomalies deduced from geotechnical data.

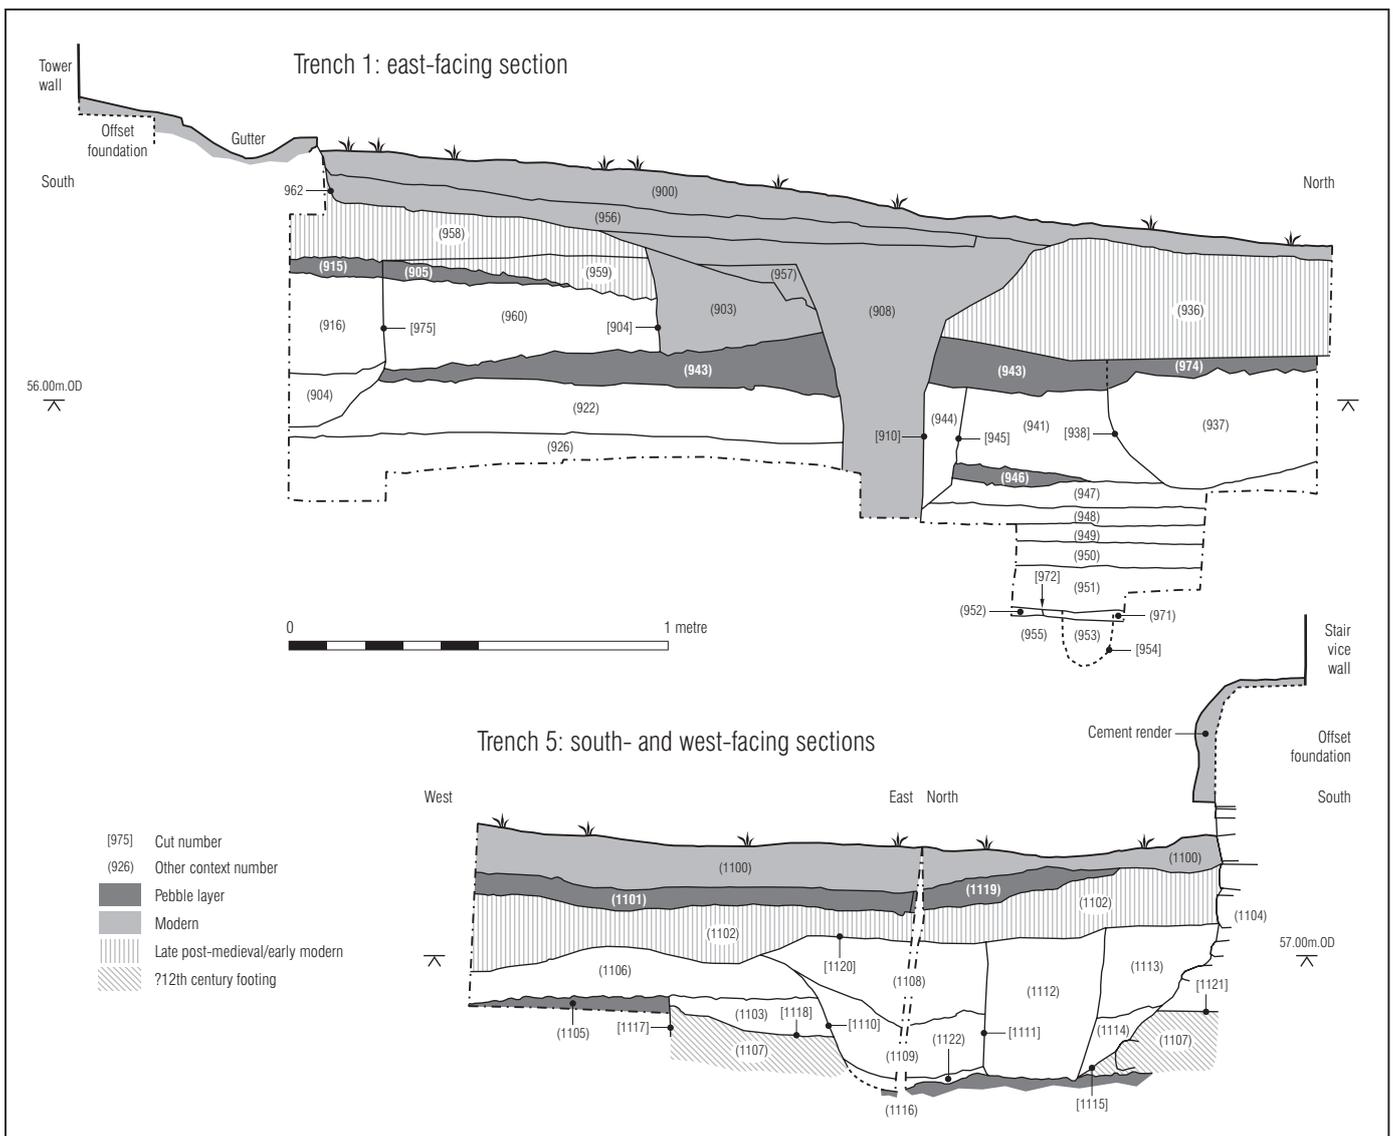
Minster Abbey, Sheppey: trench sections.

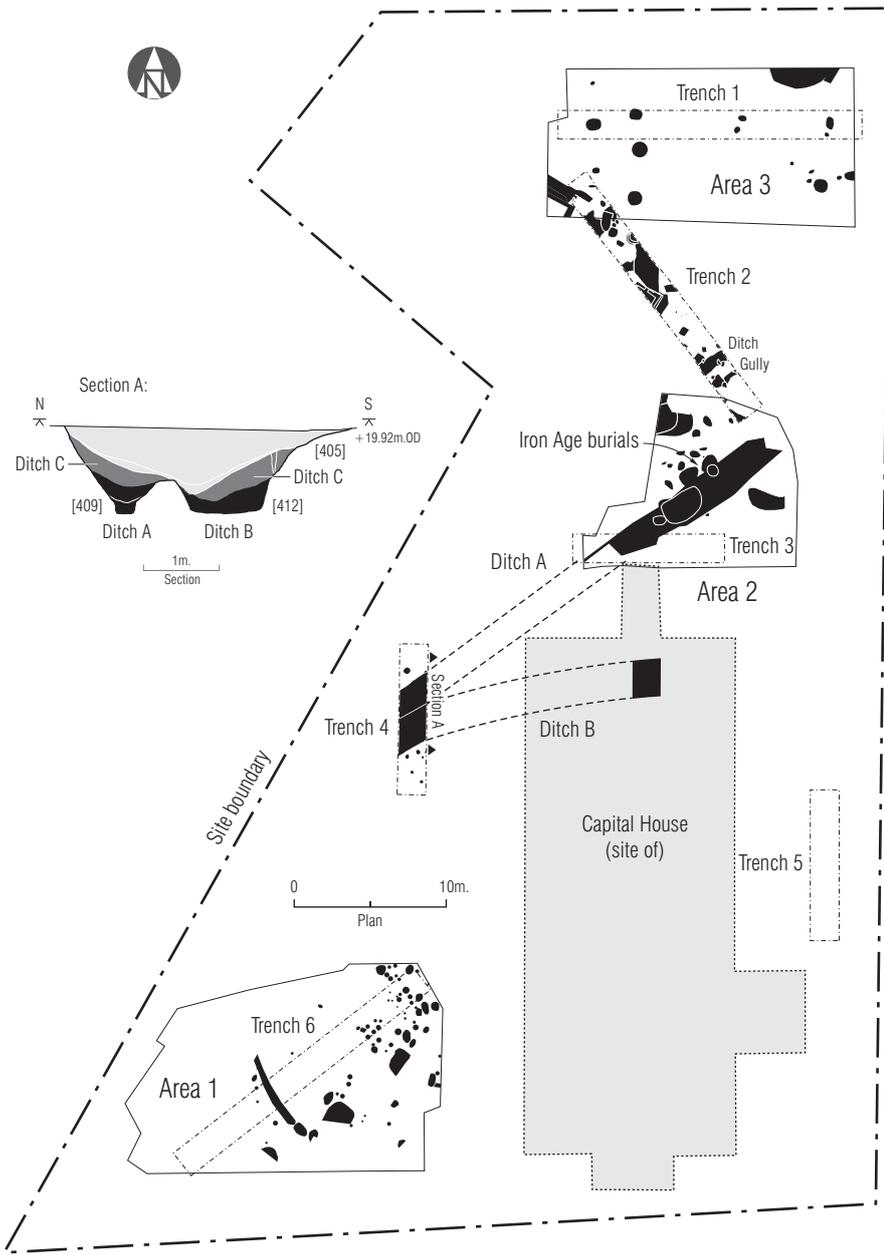
The prehistoric features (scale 1:500).

Excavation revealed a further 35m length of Ditch A in Area 2. Here it was 1.02m deep and slightly wider at 1.70m. A later recut widened the ditch to 2.20m.

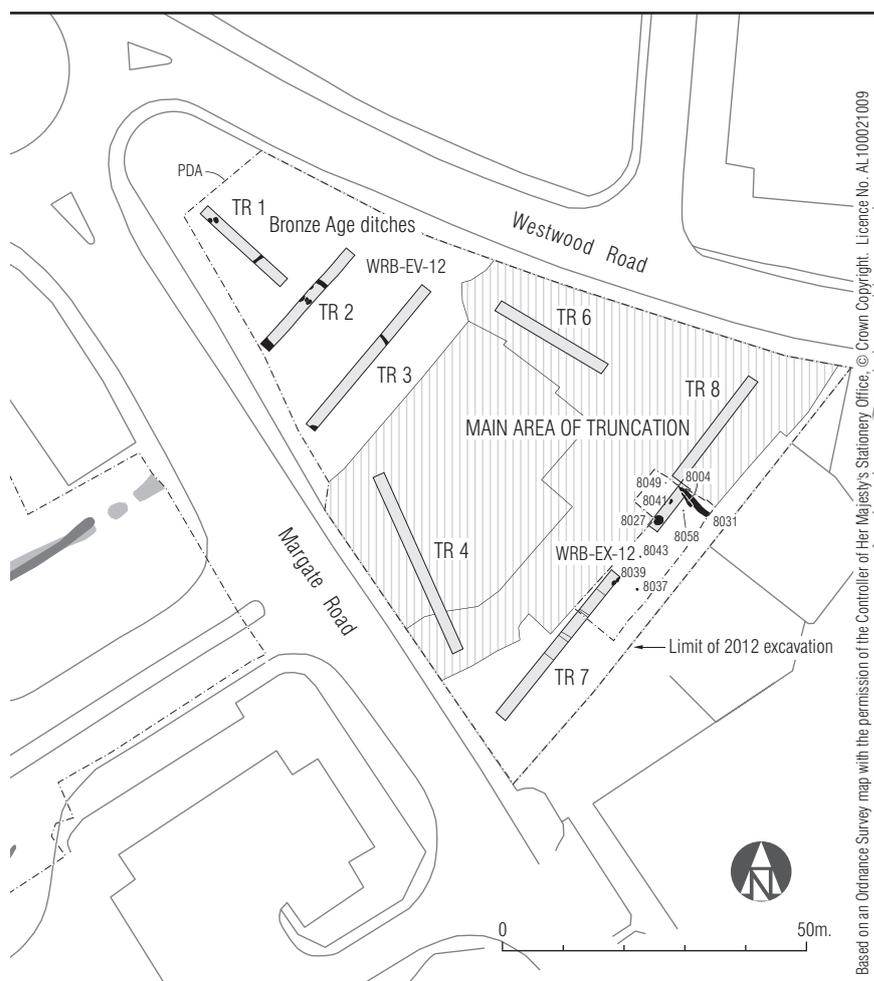
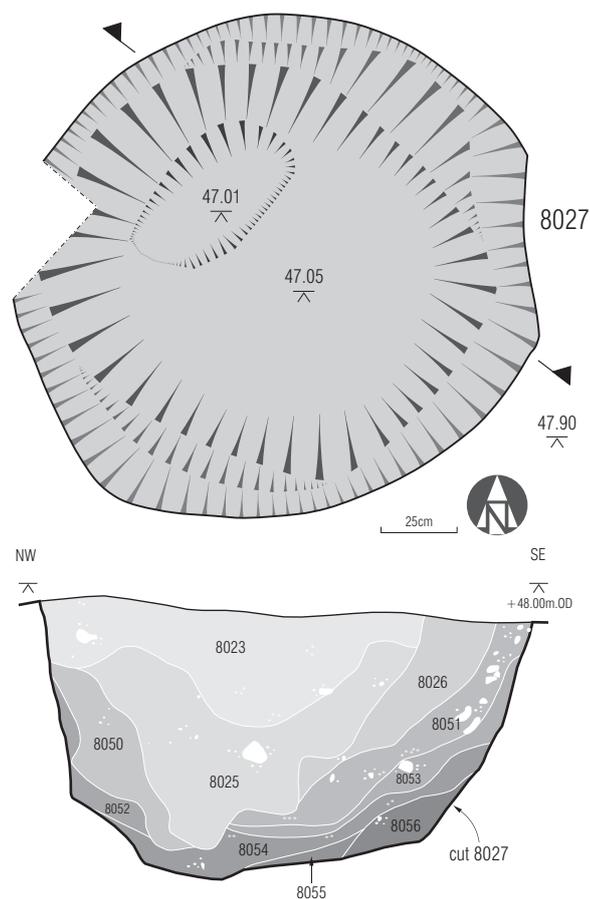
Westwood Road location plan (scale 1:1250).
Plan and section above (scale 1:25).

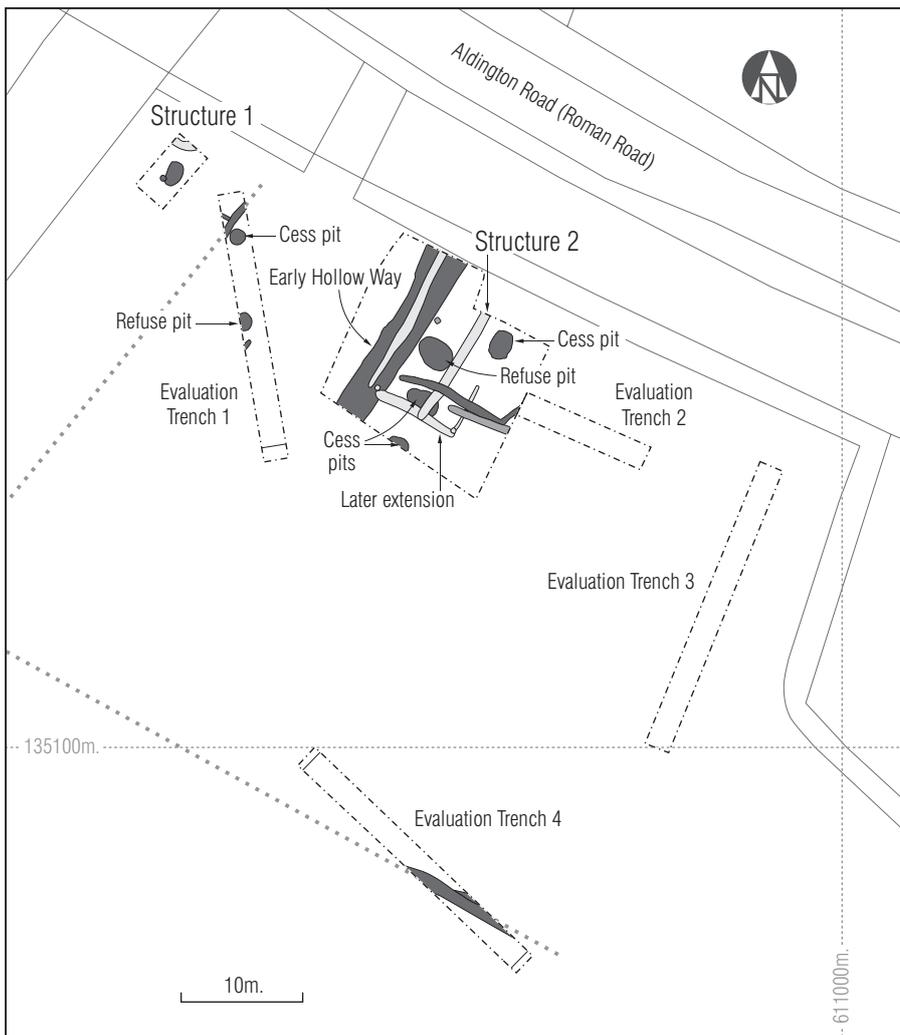
Otterpool Campsite, Lympe: excavated features.

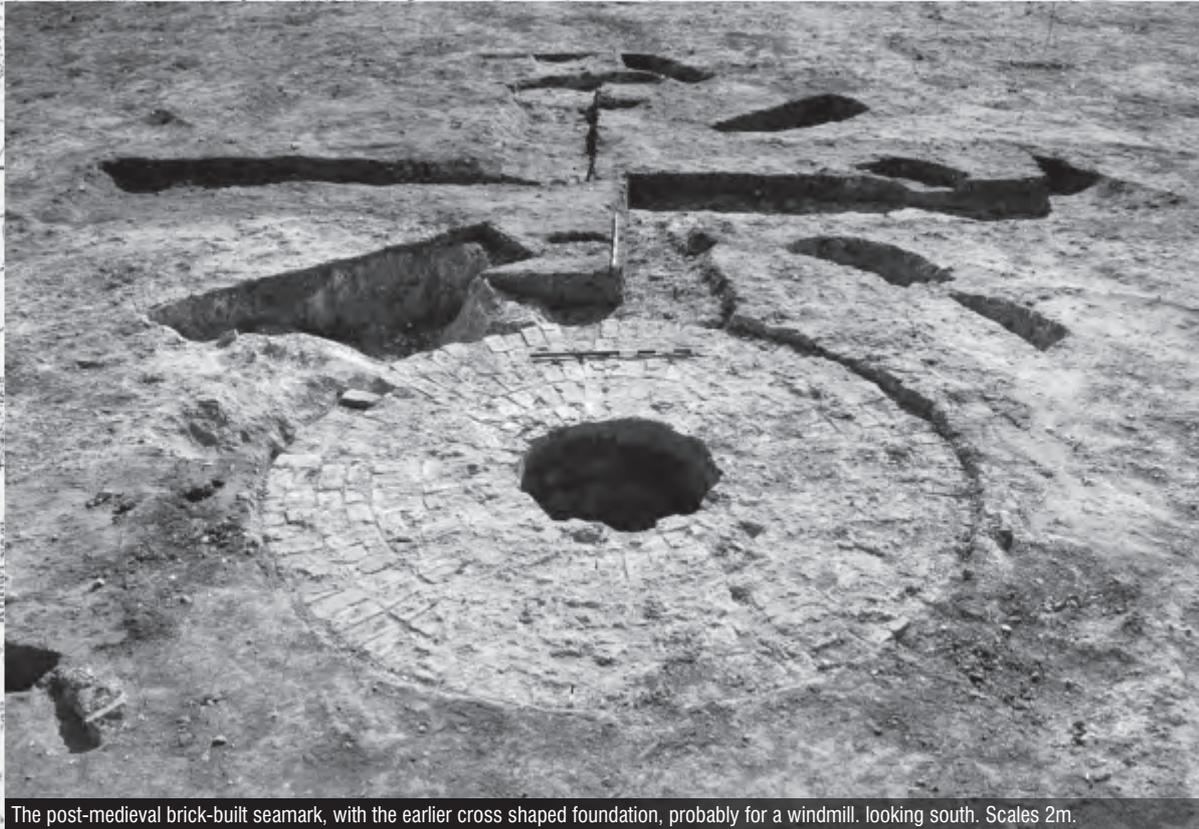
The post-medieval brick-built seamark, with the earlier cross shaped foundation, probably for a windmill. looking south. Scales 2m.

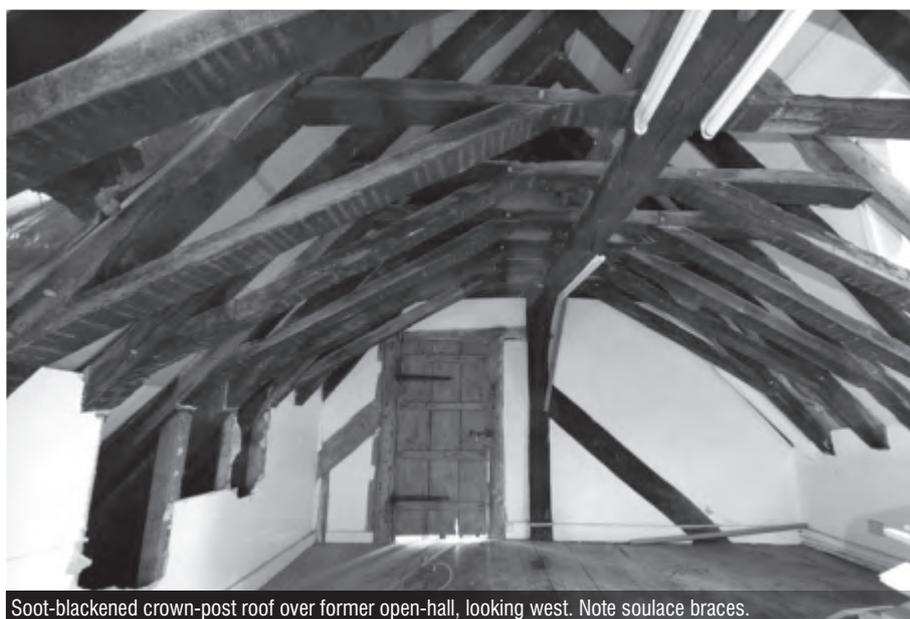
Soot-blackened crown-post roof over former open-hall, looking west. Note soulace braces.

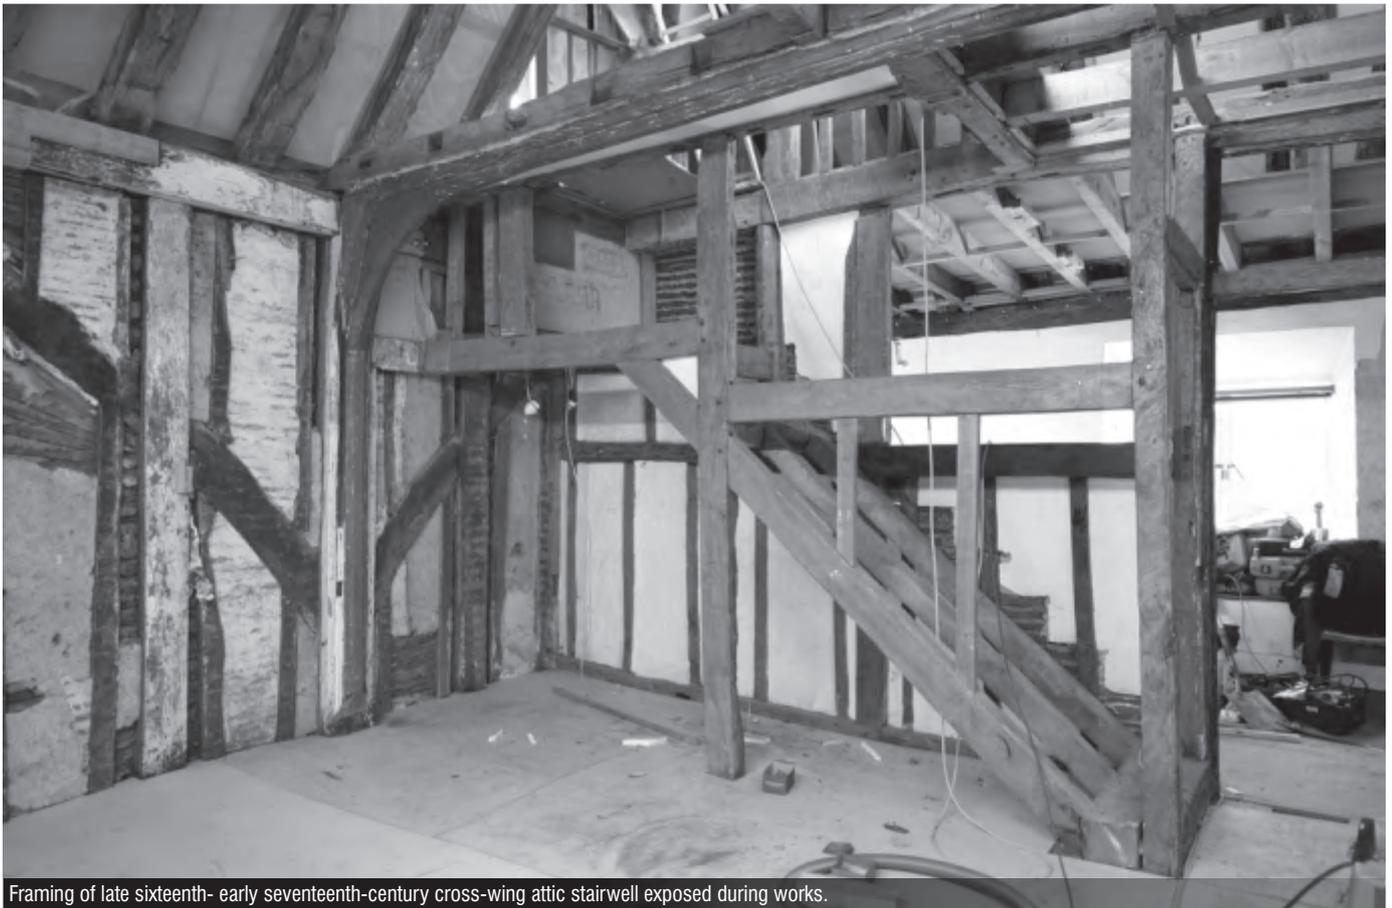
Framing of late sixteenth- early seventeenth-century cross-wing attic stairwell exposed during works.

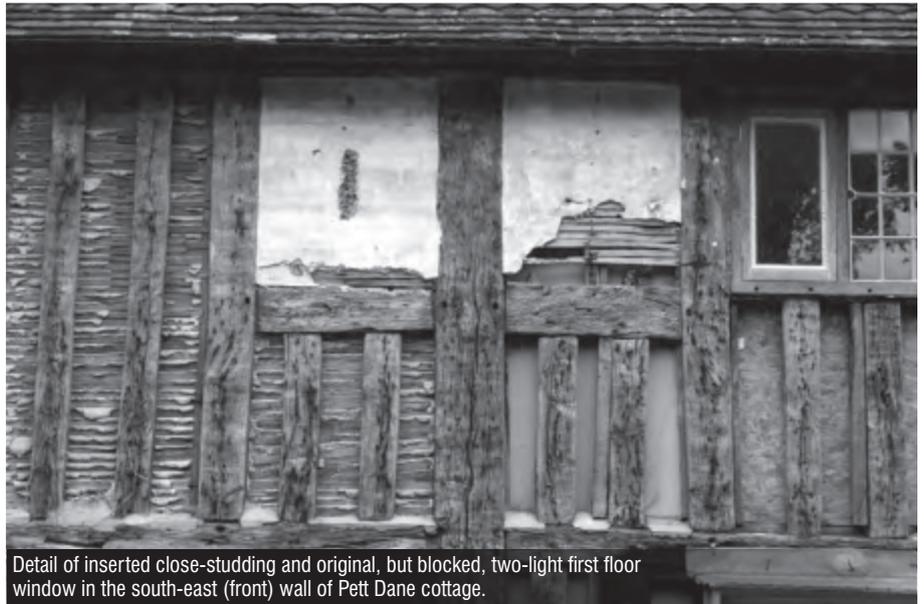
Detail of inserted close-studding and original, but blocked, two-light first floor window in the south-east (front) wall of Pett Dane cottage.

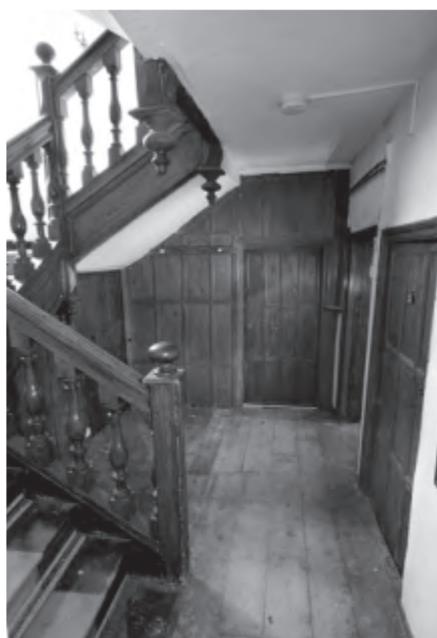
Early eighteenth-century, Period 3 staircase. Note contemporary doors and small-square panelling.

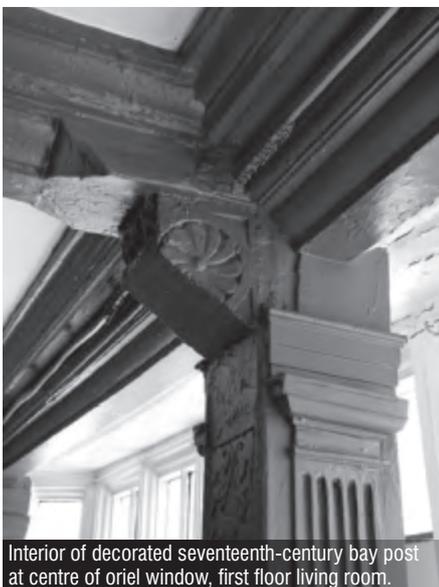
Interior of decorated seventeenth-century bay post at centre of oriel window, first floor living room.
