2004-2005

CANTERBURY ARCHAEOLOGICAL TRUST LP A REGISTERED CHARITY

Contents

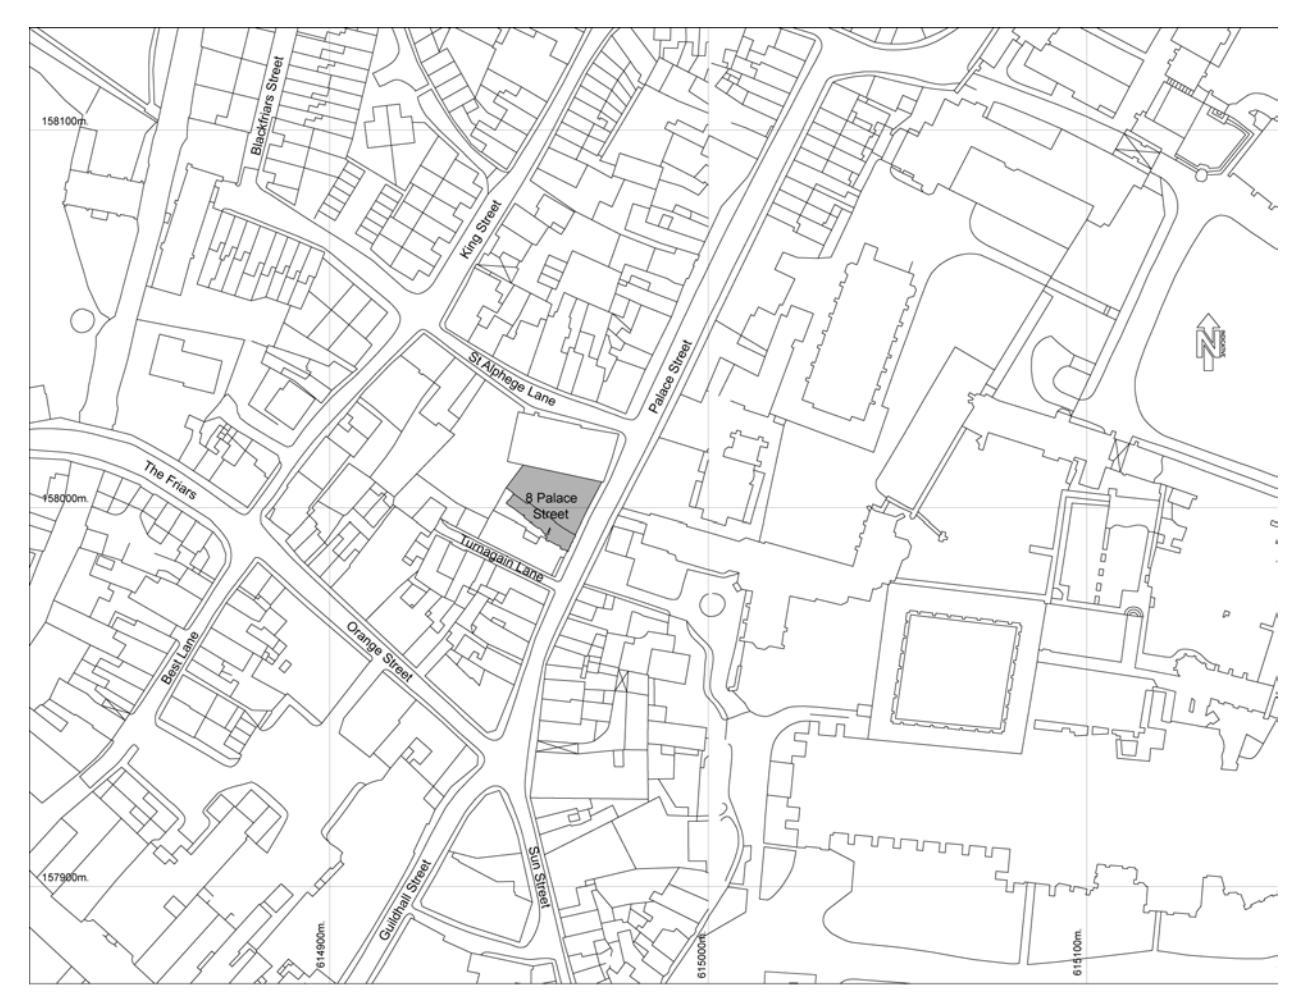
A Plan showing location of proposed development area. Scale 1:2000.

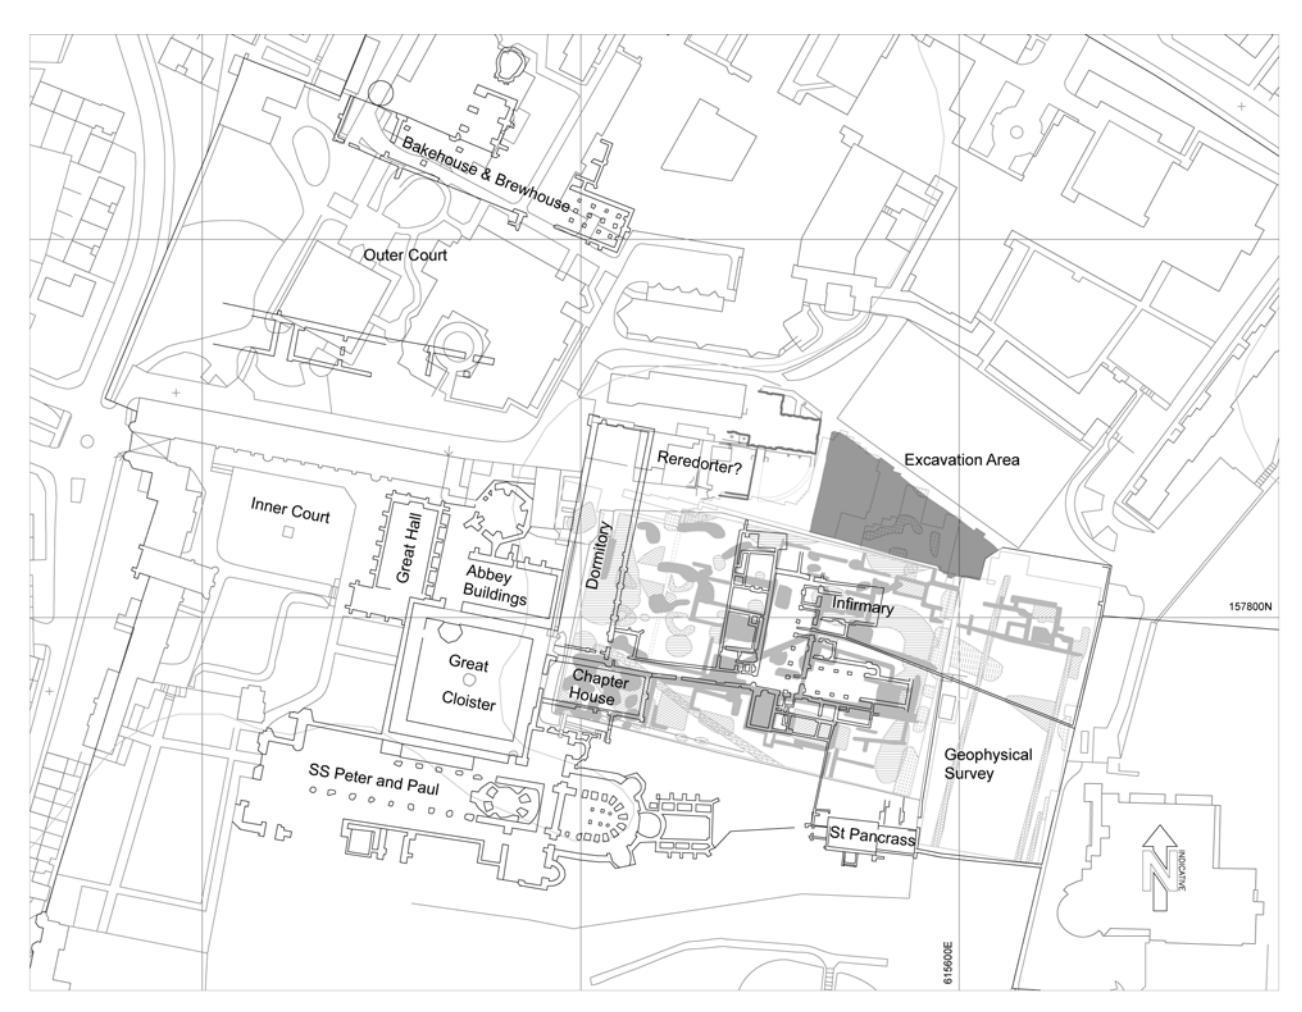
🙏 Plan showing overlay of Geophysical Survey (light grey), known abbey buildings (black) and excavated area (dark grey). Scale 1:2000.

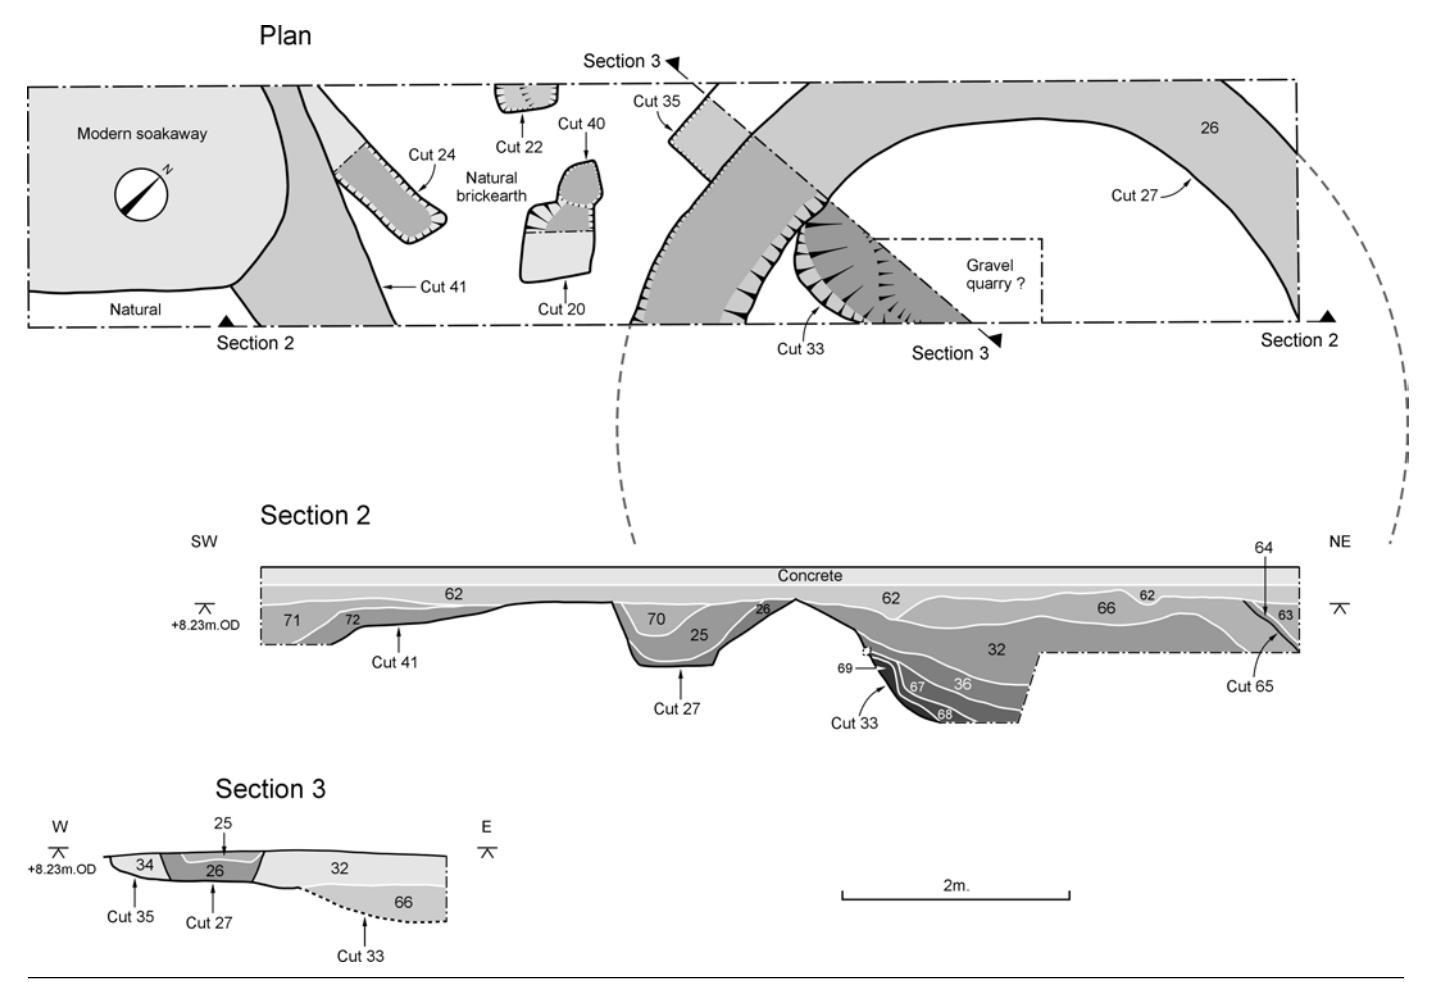
A Trench 2 plan and sections, showing eighteenth- or early nineteenth-century circular garden feature.

The remaining features and deposits found south of the mill all dated to the medieval or predominantly post-medieval periods. The earlier features across much of the site were sealed by up to a metre of what appeared to be later medieval or post-medieval dumped levels and agricultural soils related to horticultural activity. The later features were concentrated in Trenches 1, 2 and 3, situated in the garden or adjacent courtyard of eighteenth-century Barton House and without doubt relate to domestic and gardening activities pertaining to that building. They included what has been interpreted as a circular flower bed, or foundation for some form of garden structure (cut 26).

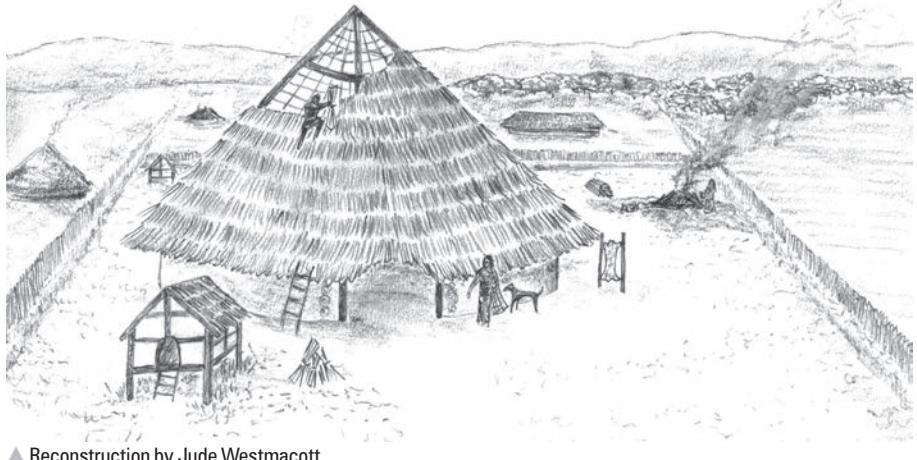
A Reconstruction by Jude Westmacott

With a diameter of c. 16 metres, this structure is comparable to the largest discovered anywhere in the country. The reconstructions at Butser [www.butser.org.uk] and Castell Henllys [www.castellhenllys.com] at 15 and 12 metres respectively, give a good idea of scale. Assuming an optimal roof pitch of 45 degrees to maximize strength and weather resistance, and allowing a metre or so for the height of the circumference wall, the great house would have been some nine or ten metres high at the apex. There are various ways to build a house of this size, but from the excavated evidence at Hersden it seems likely that the ring ditch represents a wall trench, and that posts inside this

perimeter would have supported the weight of the roof; this in turn would have been given stability by the use of one or more ring beams. In effect, the bottom ring of posts and beams stops the roof spreading, whilst the higher rings stop it collapsing inwards, giving a very stable cone. One advantage of this type of build is that, because the thatch would long outlast the wattle and daub walling, it would be possible to replace or repair the latter without compromising the structure.

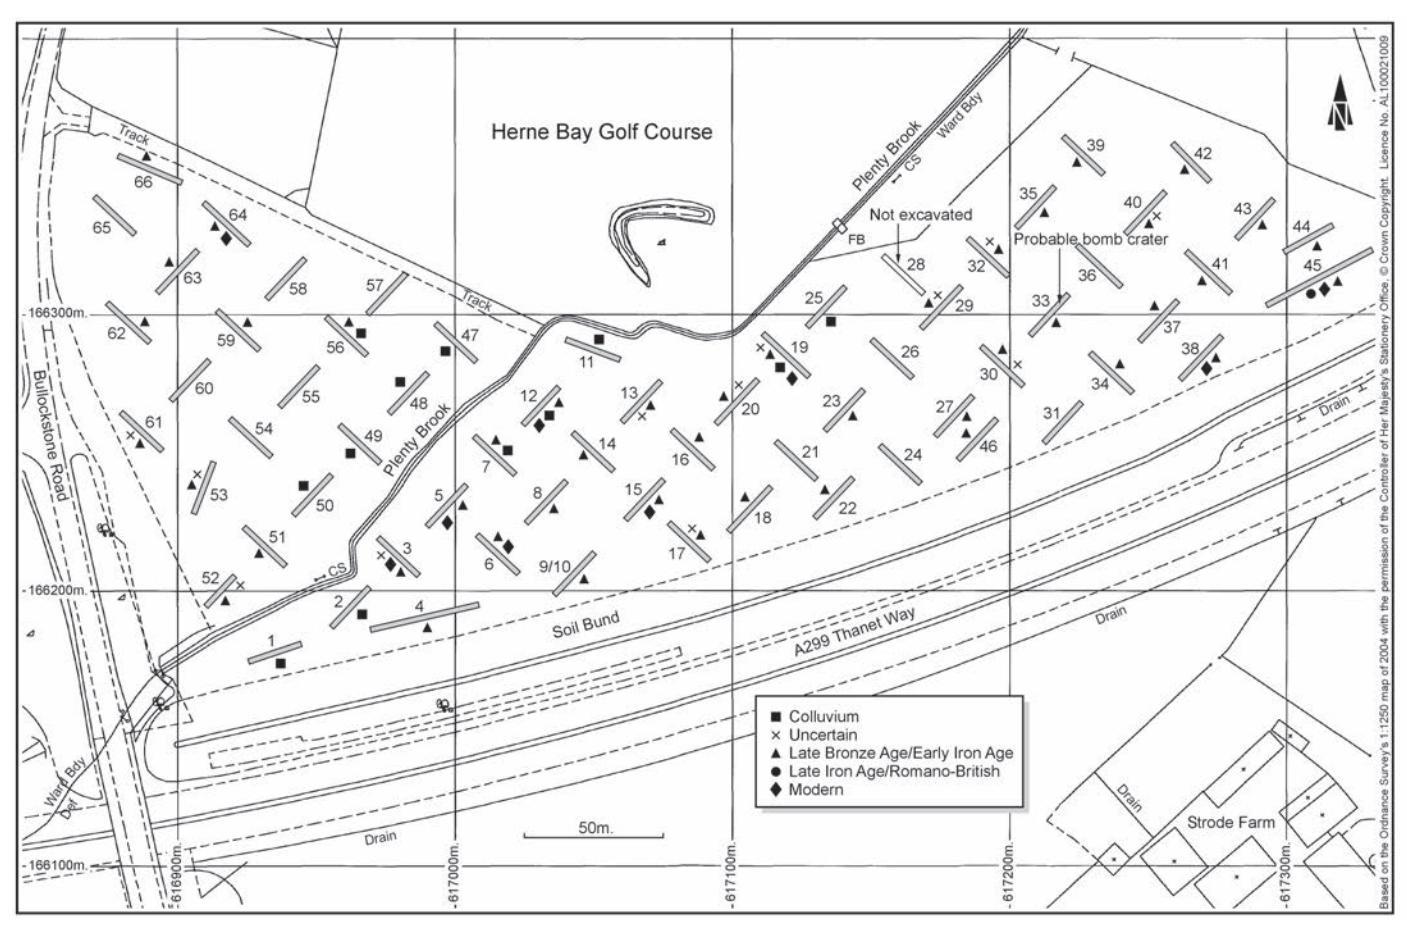
A Trench location plan showing archaeological features and colluvial deposits.

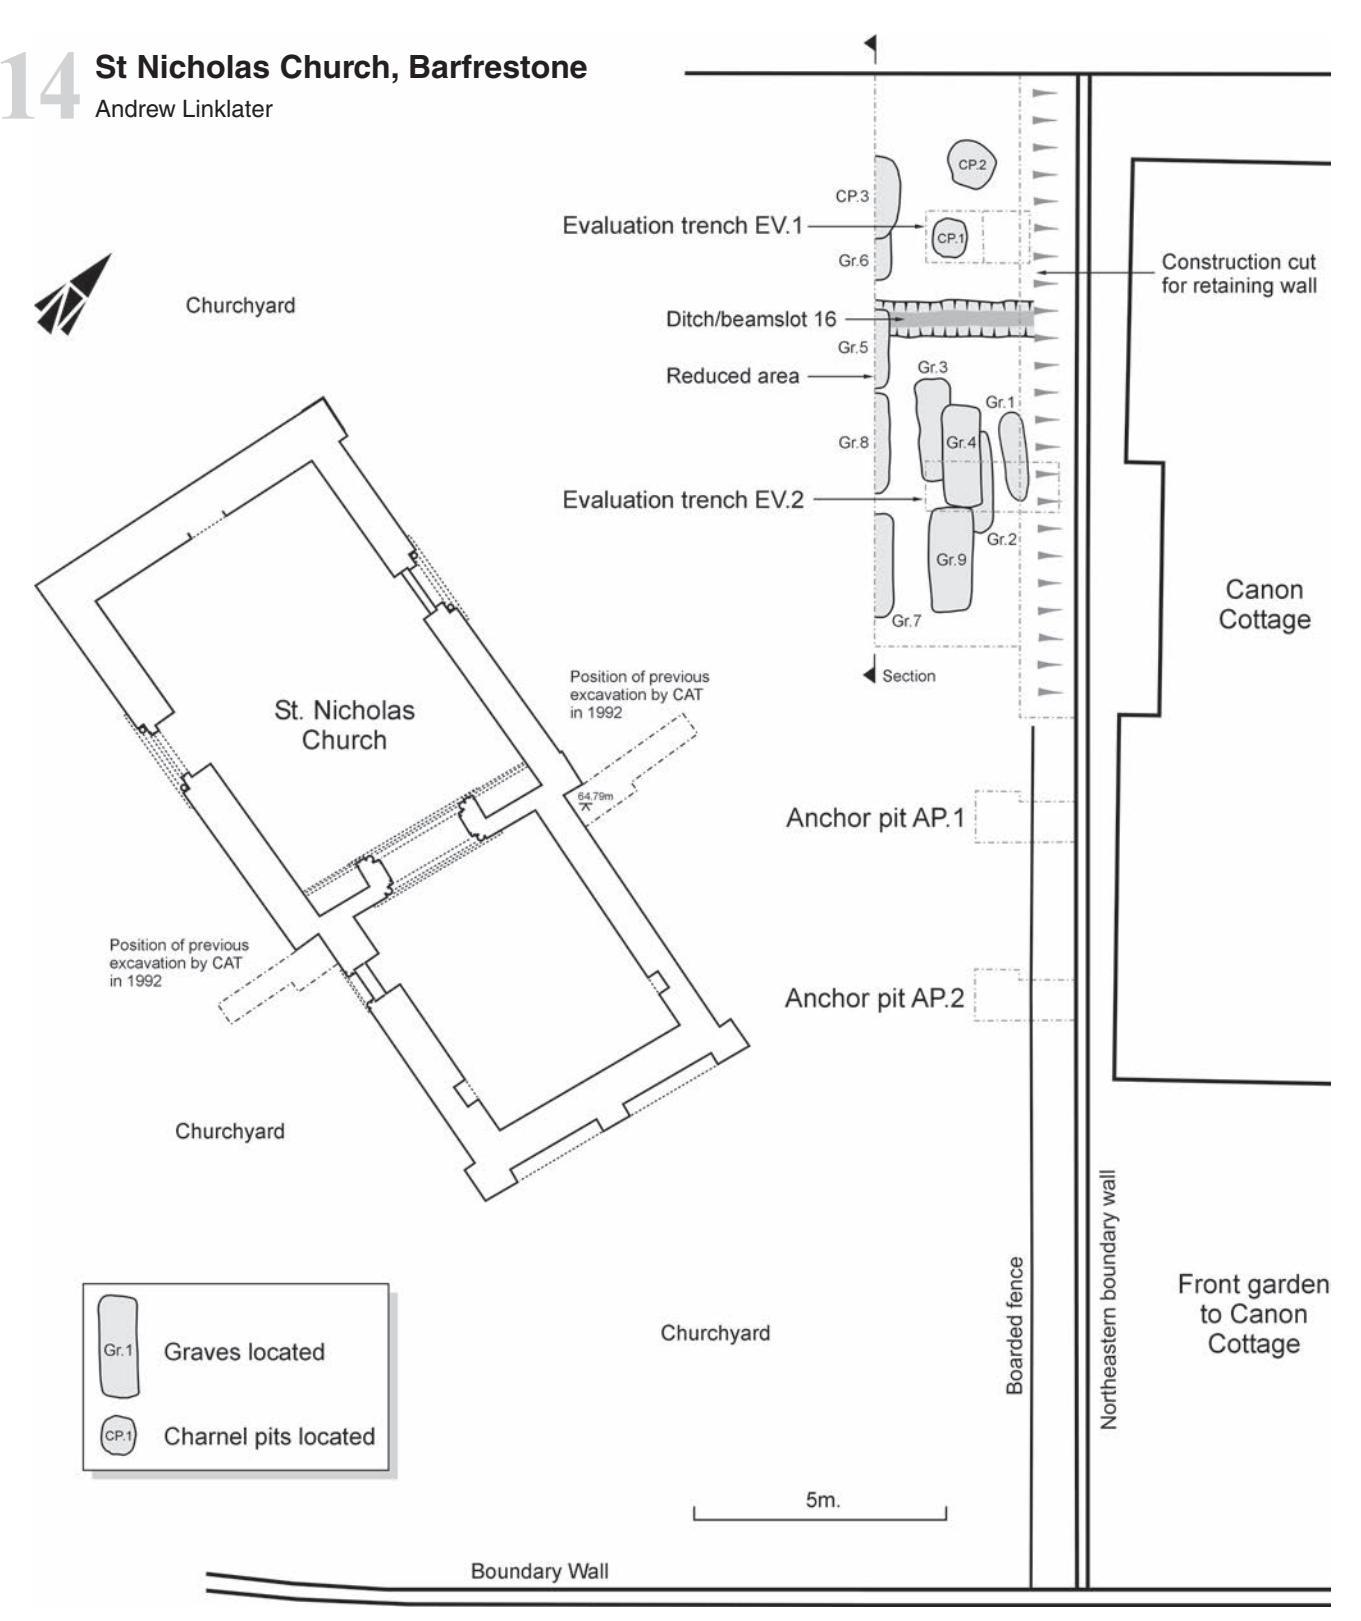
A Detail plan showing the position of the evaluation trenches, reduced area and the anchor pits in relation to the present church and churchyard. Scale 1:150.

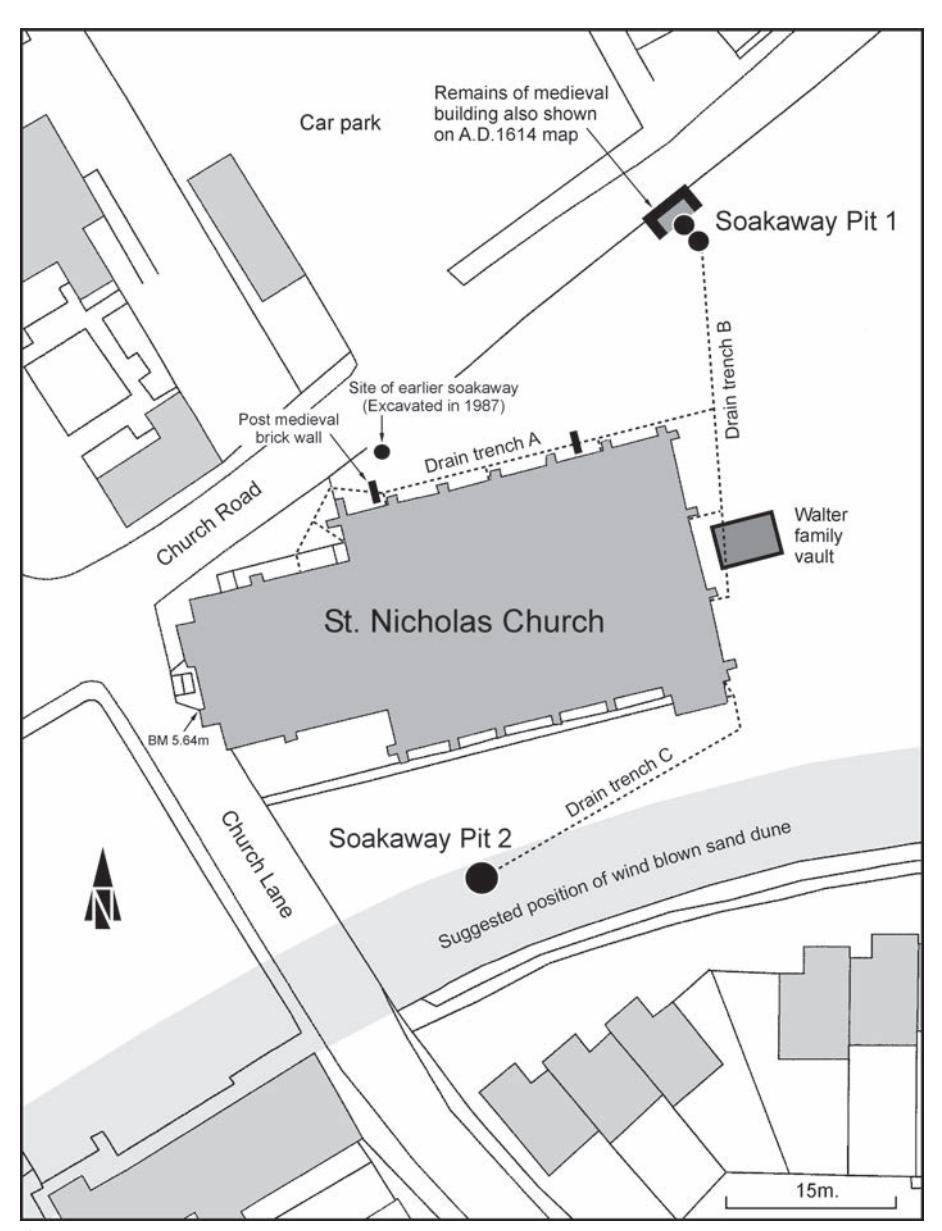
Detail from the modern Ordnance Survey map, showing the position of Drain Trenches A–C and Soakaway Pits 1 and 2 in relation to the present church and churchyard.

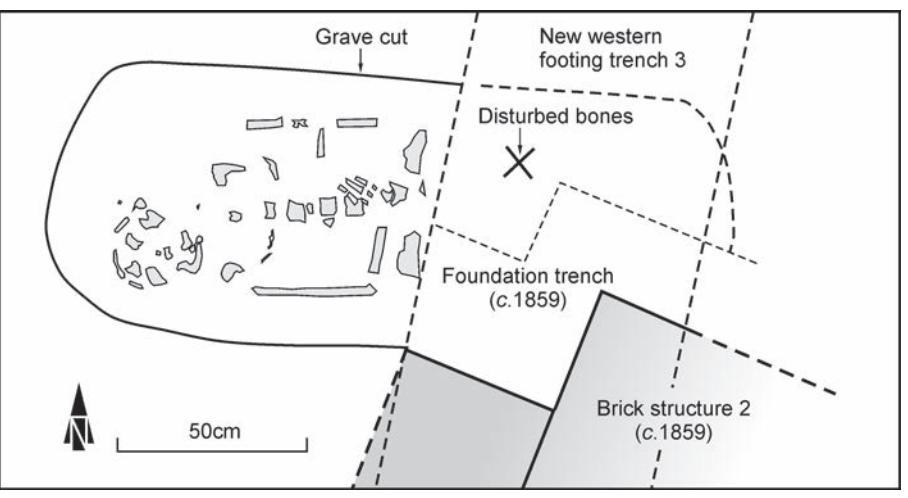
A Plan of the Roman inhumation burial.

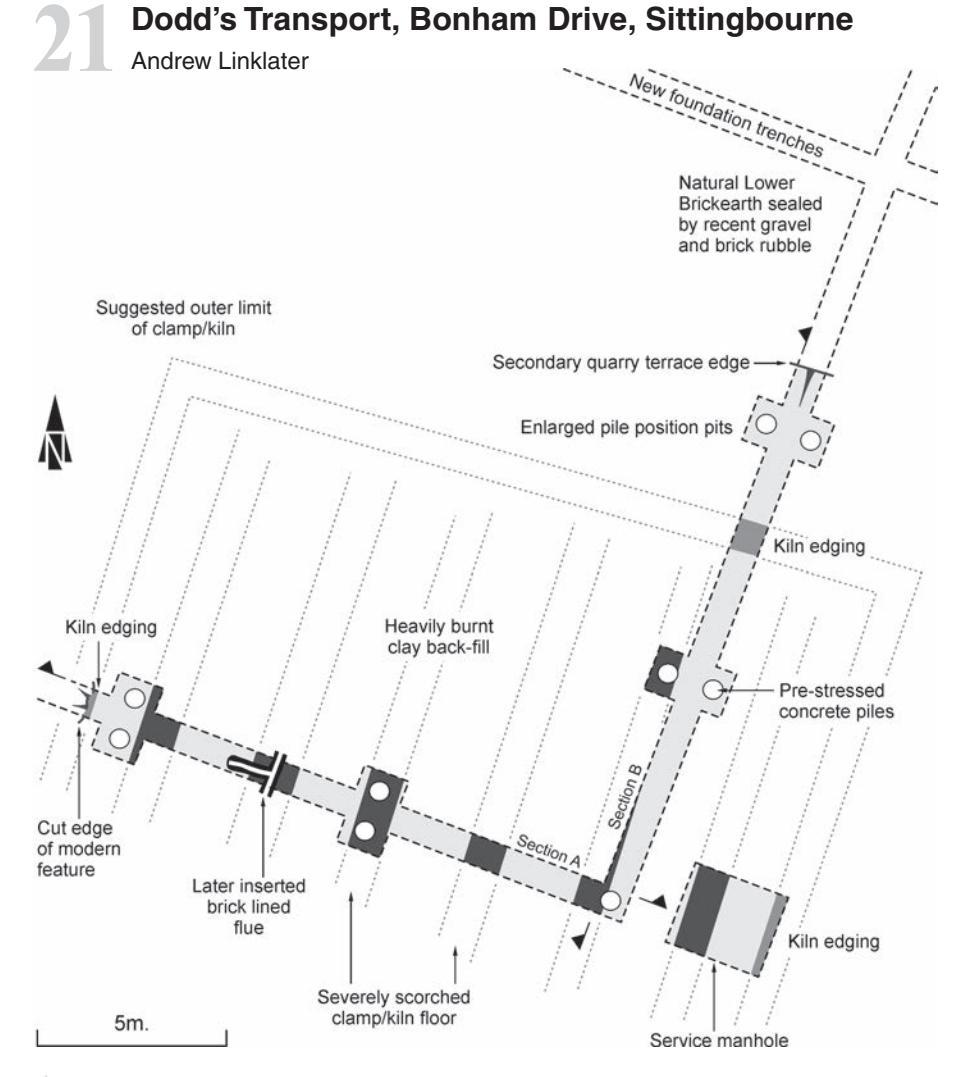
A Detailed extract from the foundation plan of the new building showing the remains of a brick clamp/kiln including a reconstruction of its plan from the available evidence. Scale 1:200.

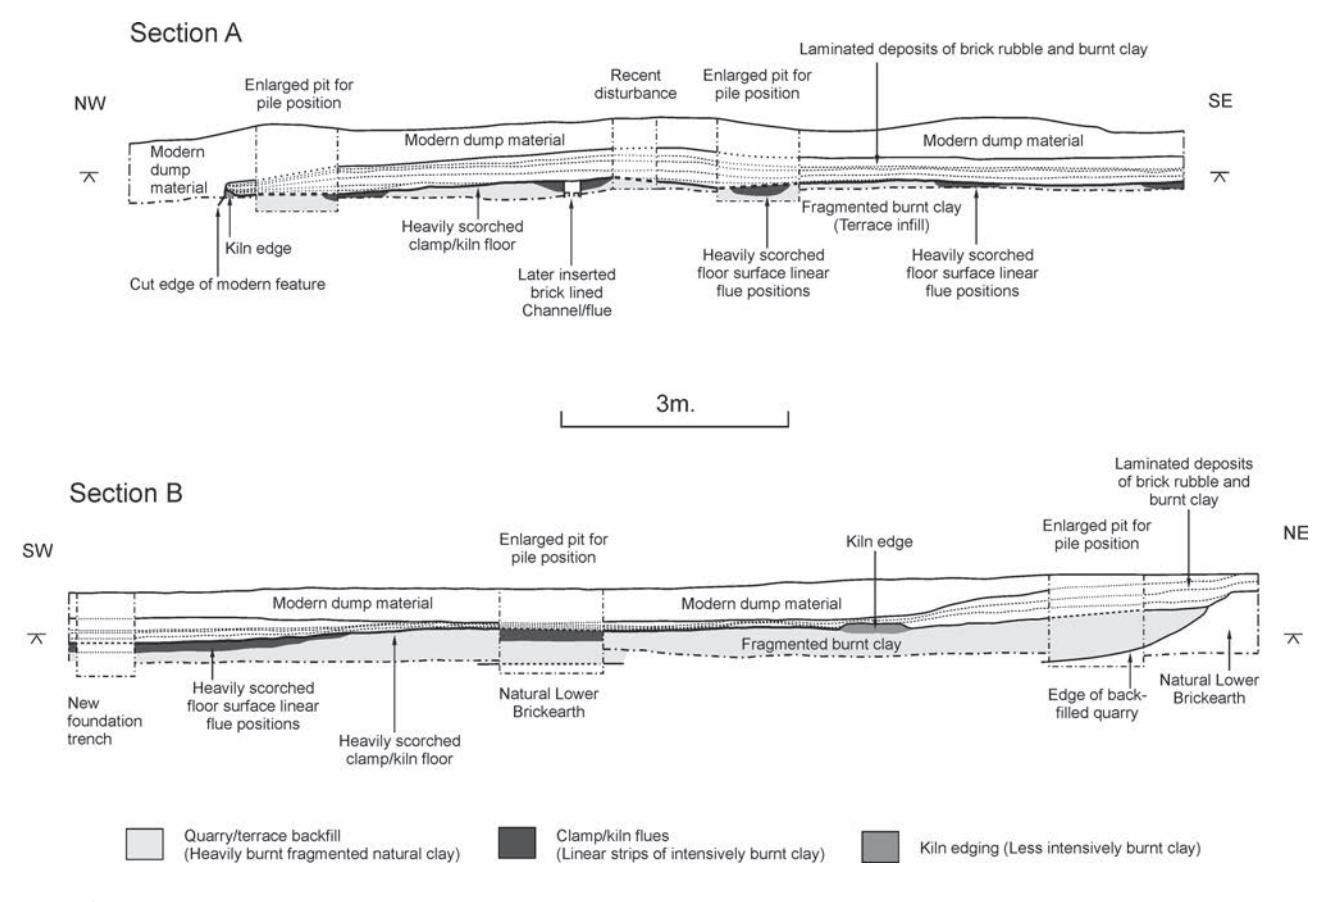
A Sections A and B, showing the remains of a post-medieval brick clamp/kiln over backfilled quarry/terrace. Scale 1:100.

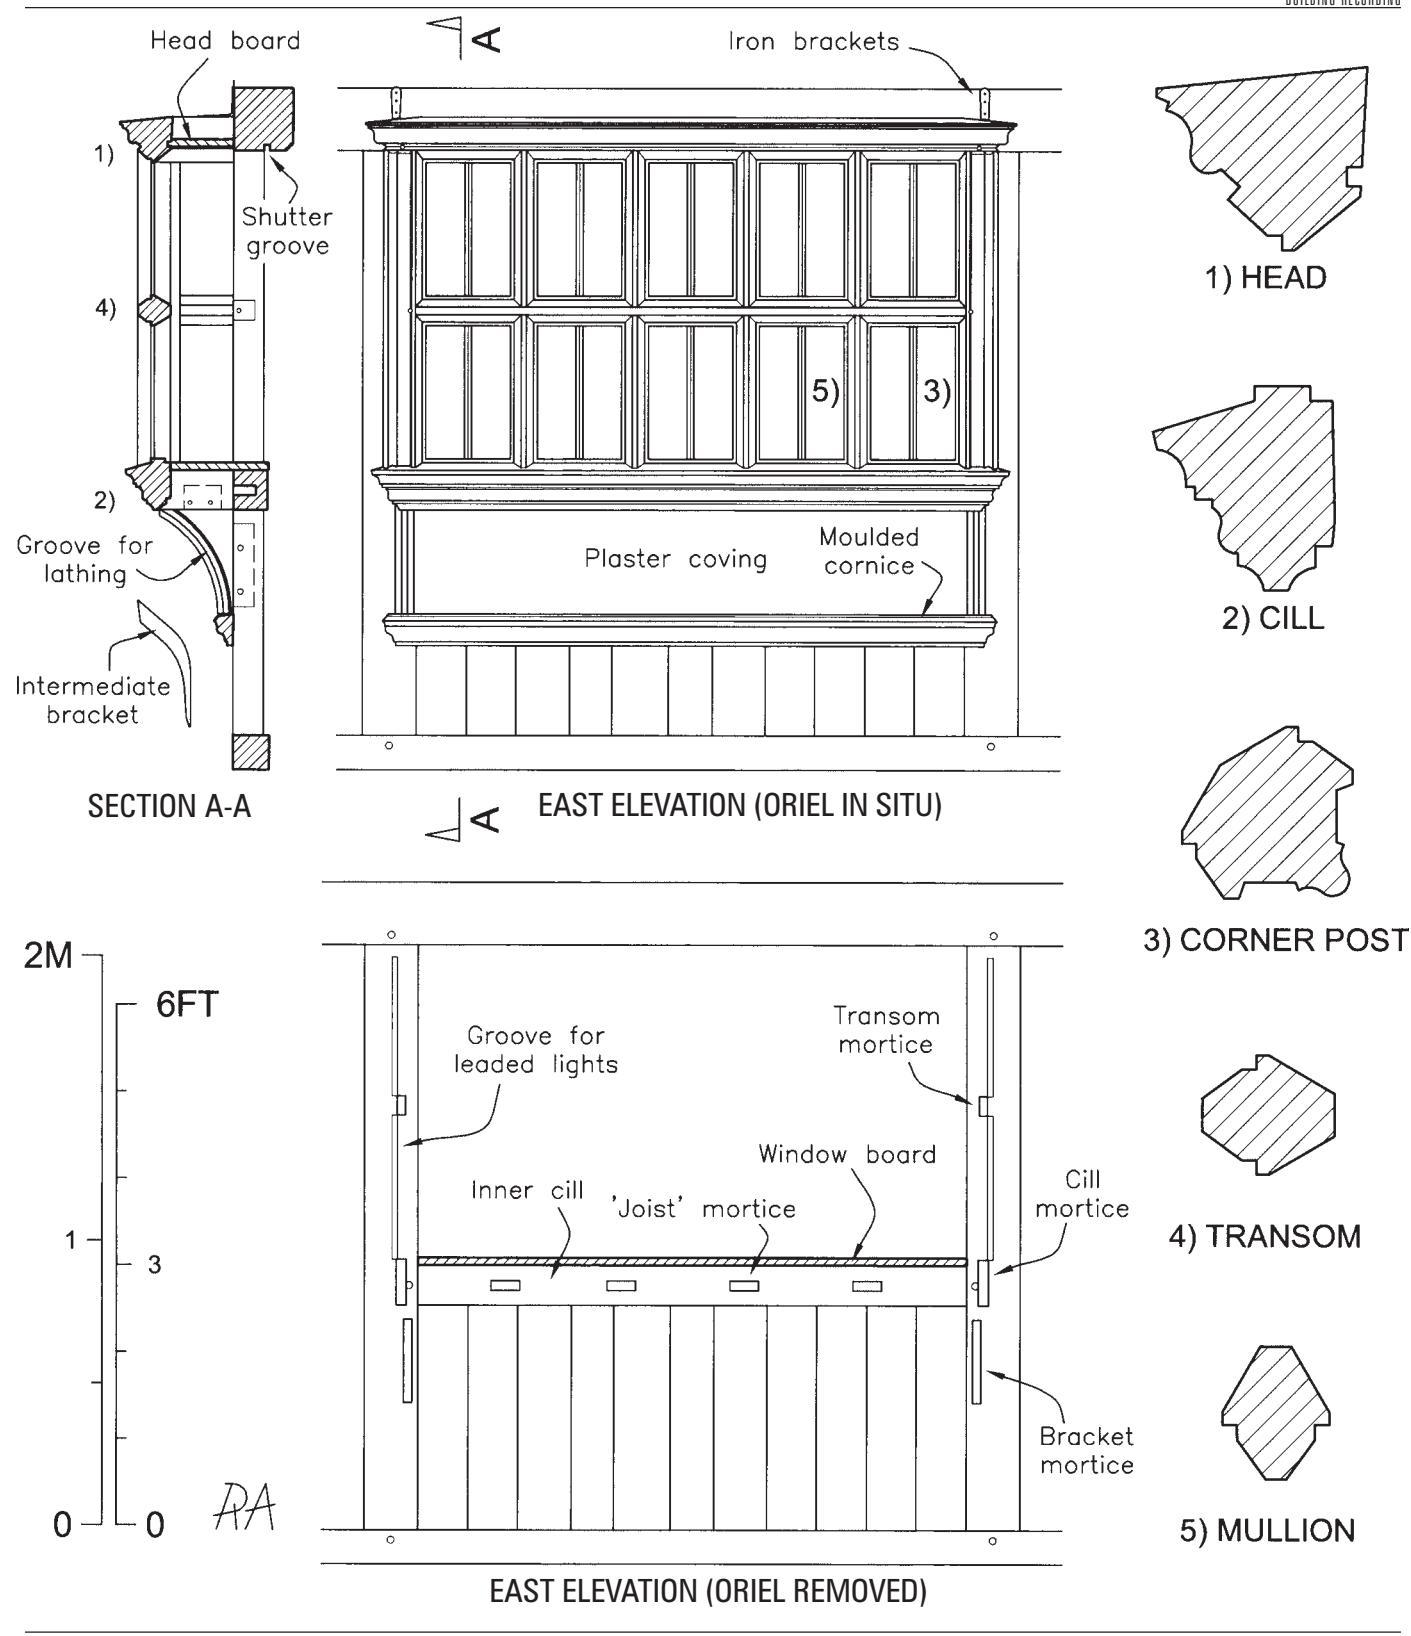
A Construction details of oriel window.
