Reconstructing a Tudor city

Teachers background notes to the reconstruction

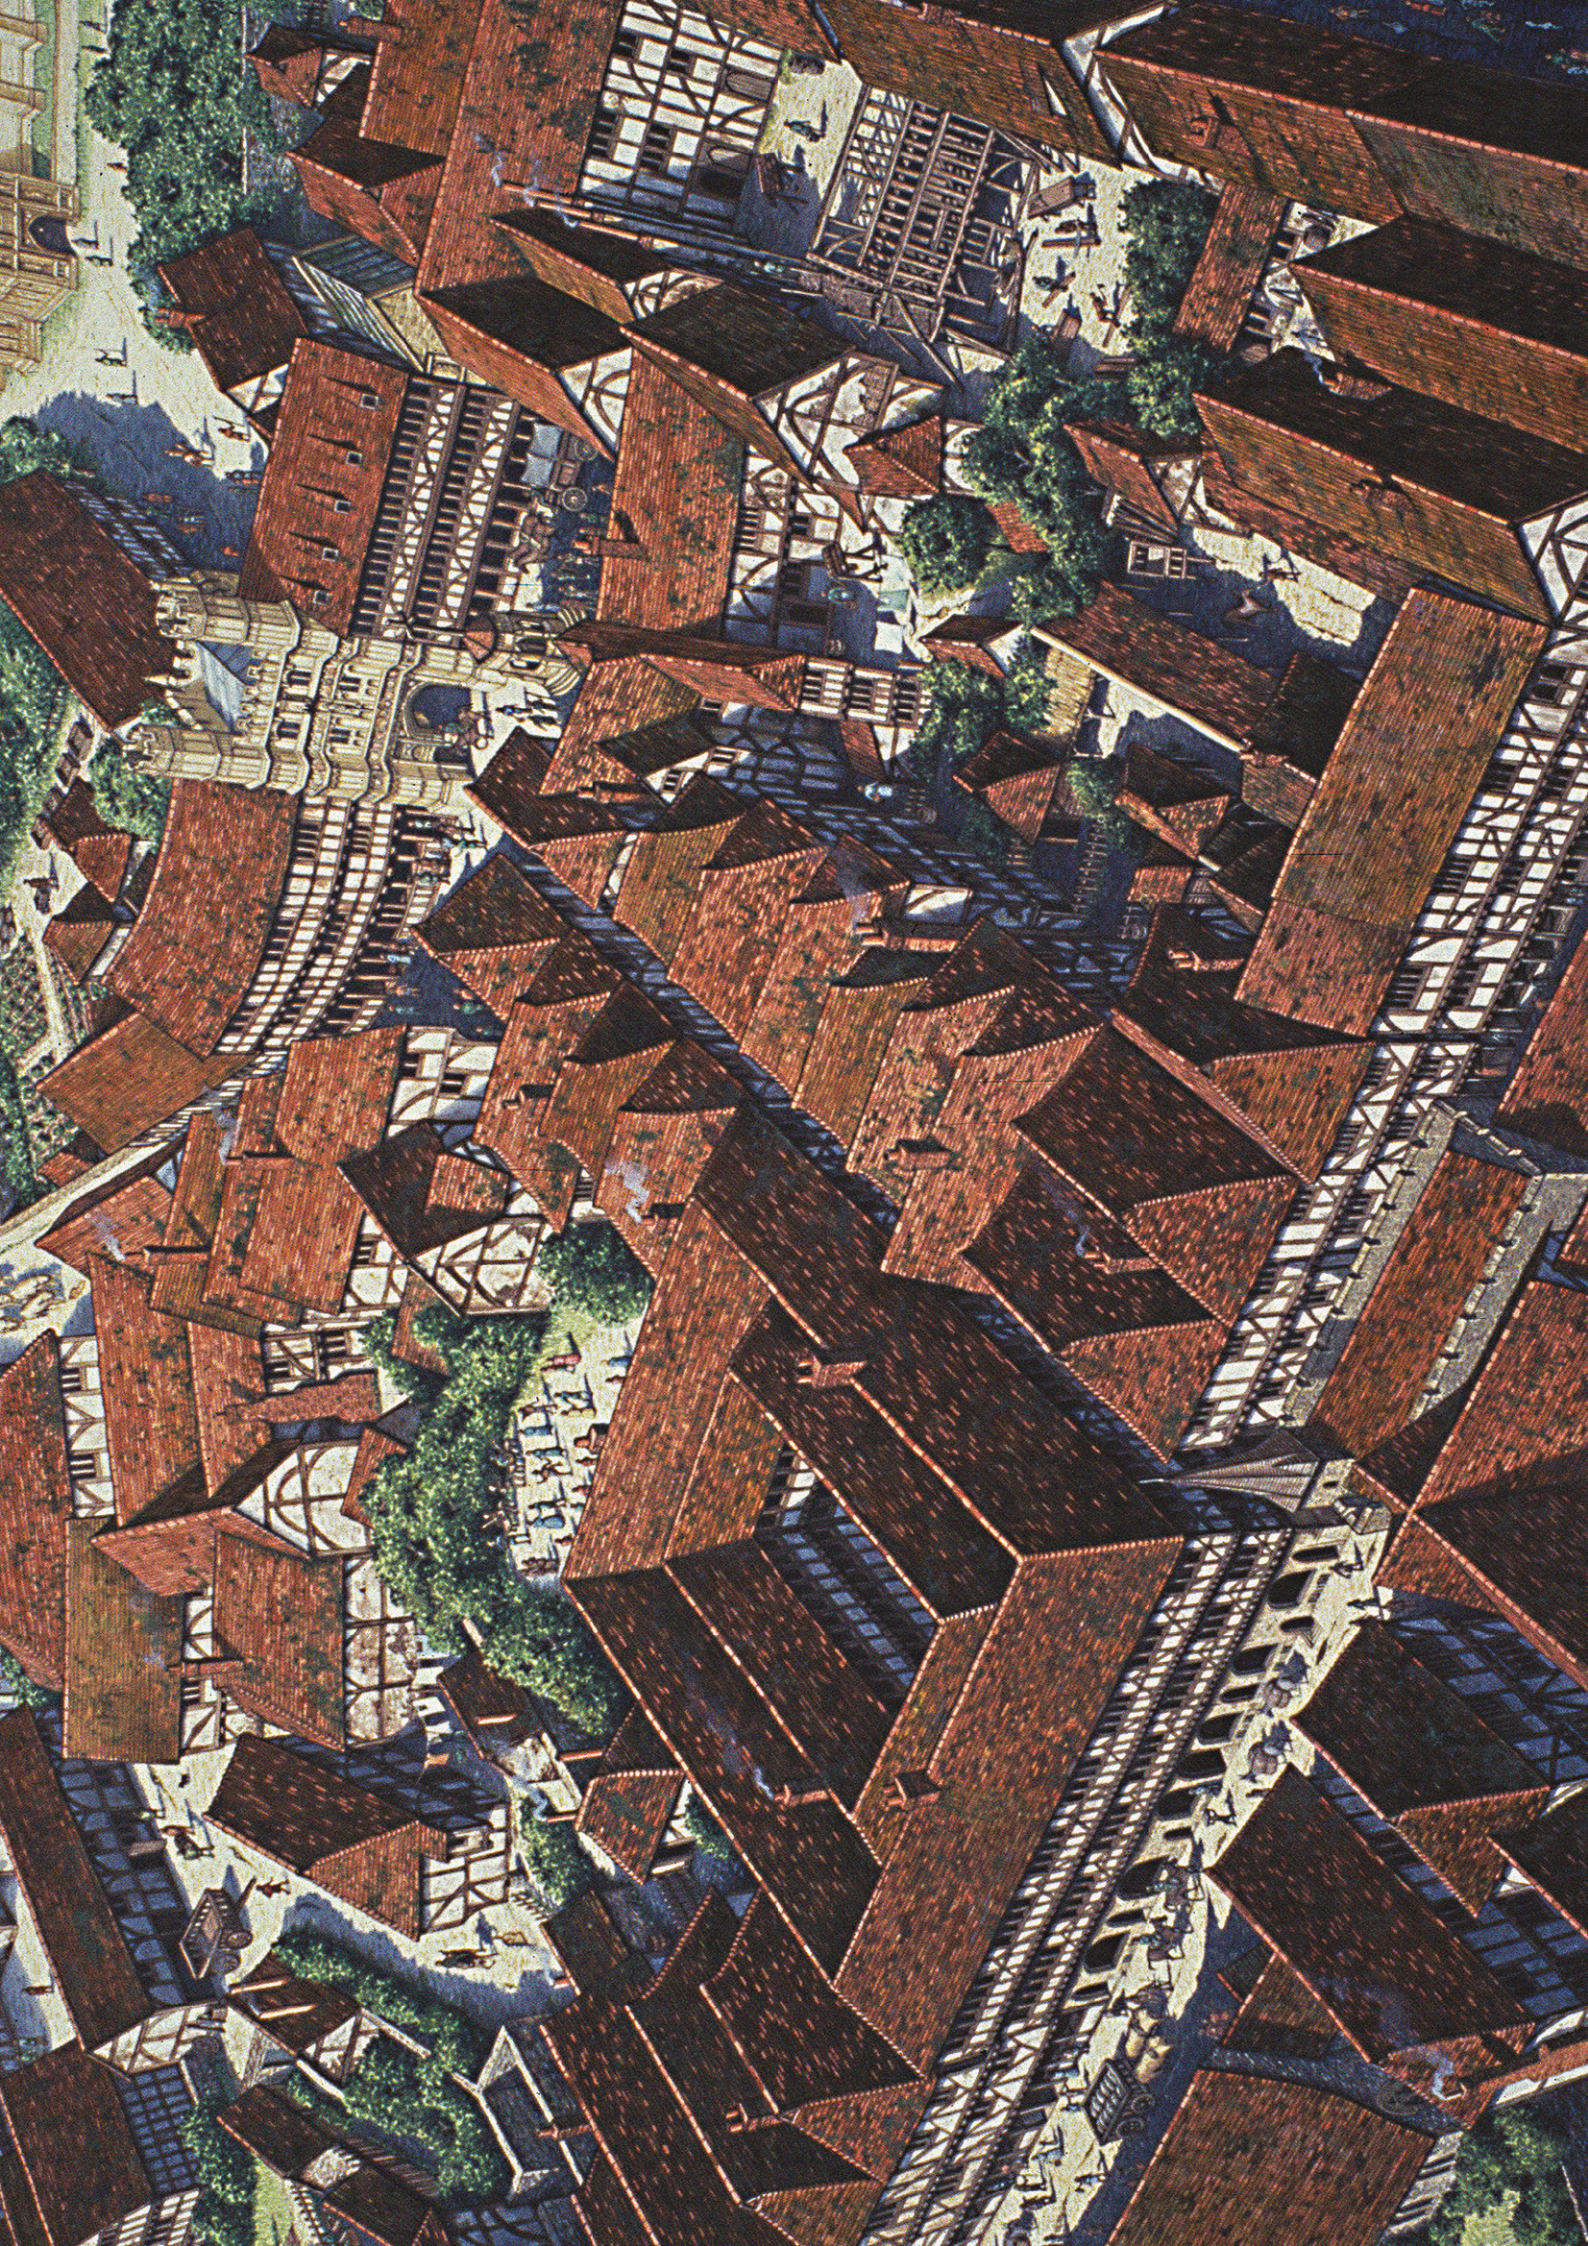
The image gives an impression of how the city probably looked just before the Dissolution of the Monasteries under Henry VIII. However many of the buildings were first built in the Medieval period. They were later renovated and altered according to need and fashion.

Note the entrance to the Cathedral precincts, top right. There are also 2 parish churches. Most of the buildings in the city centre were for commercial and domestic use. Several were built to serve the Tourist industry.

Notice that the timber frame style of building was very popular. Timber was a readily available material for building the frames. Small branches and raw clay were also easy to find, to make 'wattle and daub' walls. The wattles were woven together basket fashion with clay added to both sides. Note the tile roofs. Roof tiles, glazed floor tiles and a whole range of kitchen and table pottery was made in kilns just 3 km north of the city in the Tyler Hill area (hence the name). From c.1150 to the early 20th century an extensive potting industry exploited the London clay beds found there. The closest excavated remains to the city are from the campus of Kent University and grounds of St Edmund's School.

The 2 parish churches were built with flint and other stones. Stone imported from the continent was used for Christ Church Gate (see below).

This masonry gate is top right in the image, leading into the Cathedral precincts. It was built in 1517 (inscribed in Latin above the gateway). The Church was a wealthy institution and could afford to pay for it to be built with stone imported from Caen in France. Both the gate and the Cathedral itself were built using Caen stone. The Caen quarries were near to the French coast and it was relatively easy to ship the stone over to the south-eastern coast of England. Cargoes may well have been unloaded at the port at Fordwich and then taken by cart to Canterbury.

Where Mercery Lane meets the High Street you can see the tower of St Andrew’s church which seriously obstructs the main route through the city. It was demolished in 1763. To the left of St Andrew’s further down the High Street stands the medieval church of St Mary Bredman. This church was rebuilt in 1822 and finally demolished in 1900.

In front and just to the right of Christ Church Gate stands a 15th century market cross in the area then known as the Bullstake (now the Buttermarket). This was one of the main meat markets, its name deriving from a stake standing at its centre where unfortunate animals were tied for baiting. The theory was that this made the meat tender. It is interesting that today we would claim that such stress would have the opposite effect! Where the ancient market cross once stood, there is now a memorial to the people of Canterbury who died in World Wars I and II.

This lies on the immediate right of Christ Church Gate, looking at the image. It was built by Christ Church Priory in 1437–38. It was damaged by fire in the early 19th century and the eastern end (now ‘Cornell’, the jewellers) has been largely rebuilt. Substantial parts still survive today as ‘Starbucks’ (ground floor) and ‘The Cathedral Gate Hotel’ (first floor).

Adjacent to The Sun Inn stands The Bull Inn, built in the mid-15th century. It begins in the Bullstake market place and turns the corner into Burgate street. Of the surviving remains of the Pilgrim Inns, this is probably the most visually impressive. The projecting jetties (from the French *jeter* meaning to throw out) of the upper floors were a popular architectural style. We do not know the origins but it may well have something to do with making construction easier. There is also extra space on the larger, jettied upper floors. Today this extensive property is occupied by a number of separate businesses beginning with ‘Graham Greener’ gift shop in the corner of the Buttermarket. Next to this is ‘Steamer Trading Cookshop’ which turns the corner into Burgate Street. Steamer Trading’s neighbour is ‘Cafe Cultura’ and then finally ‘Blacks’. In its time, The Bull Inn was made up of different shops and pilgrims and other visitors were accommodated above.

The Crown Inn stands on the corner of Mercery Lane where it meets the Bullstake market place. It is the relatively small building at the top left-hand corner of Mercery Lane. In 1535 a room in the inn was known as ‘Sandwych Chamber’. The vaulted cellars of the inn are now occupied by ‘Debenhams’.

Travelling from The Crown along Mercery Lane towards the High Street, just short of half way down on the right-hand side you meet the corner of the impressive Cheker of the Hope. This inn was built by Christ Church Priory in 1392 at a total cost of £867. 14s. 4d. The building is almost square in plan with a galleried central courtyard. Follow the line of the inn along Mercery Lane to where it turns a right angle into the High Street. Notice the stone arcading on the ground floor along the High Street frontage. This contained shops and part of it still survives. You can see it at

the Mercery Lane/High Street corner where 'Mr Simms Olde Sweet Shoppe' is currently located. Unfortunately the left-hand side of The Cheker (as you look at the image) was destroyed in a great fire in 1865. Even in recent years, a number of small fires have broken out in the timber framed roofs of properties along the High Street and Butchery Lane (extreme bottom-right of image).
